Your Inspection Report

200 Wellesworth Drive
Toronto, ON M9C 4S1

INSPECTION DATE:
Monday, August 26, 2024

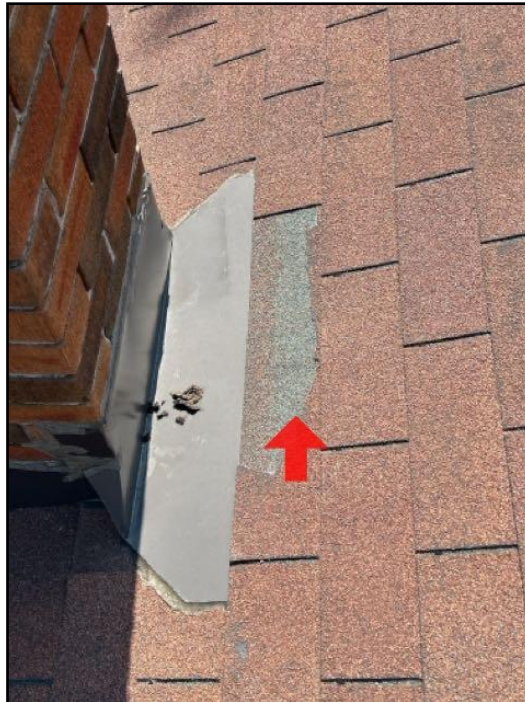
Condition: • [Missing, loose or torn](#)

Implication(s): Chance of water damage to structure, finishes and contents

Location: East

Torn

Task: Repair

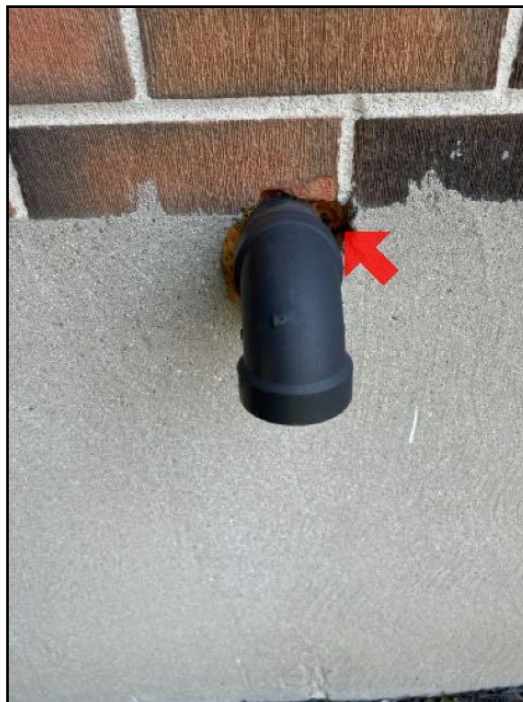
Condition: • [Caulking missing or ineffective](#)

Implication(s): Chance of water damage to structure, finishes and contents

Location: West

Caulking missing or ineffective

Task: Repair

**Seller reports
this repair complete**

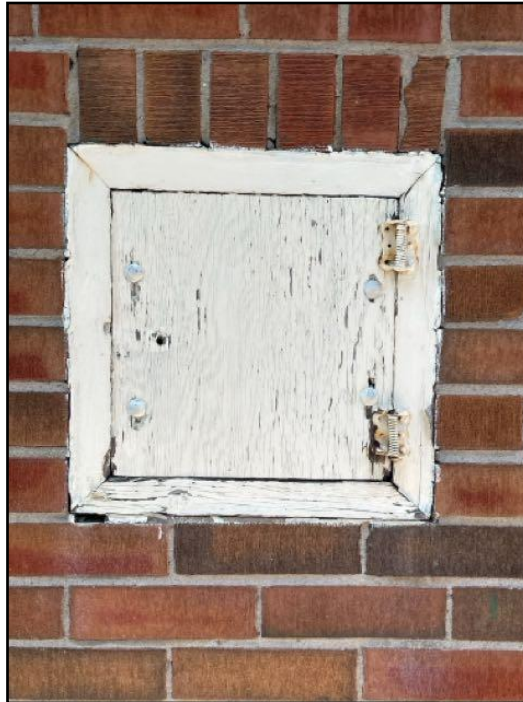
Condition: • Abandoned milk box

Abandoned milk box

Remove door and frame; patch opening.

**Seller has caulked
& painted.**

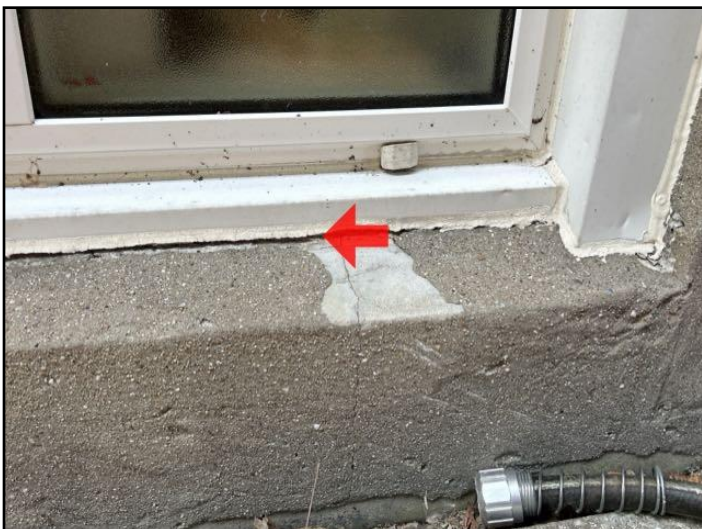
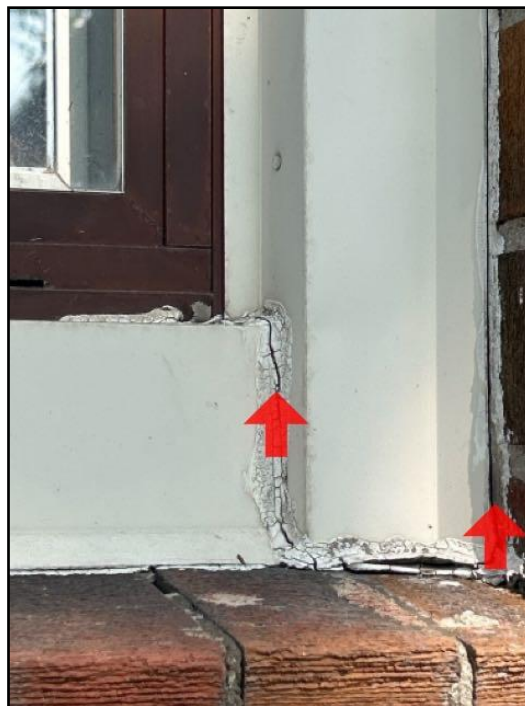
Condition: • [Caulking missing, loose or deteriorated](#)

Implication(s): Chance of water damage to structure, finishes and contents

Location: East, South

Caulking missing, loose or deteriorated

Task: Repair

Seller has completed caulking in all three areas noted here.

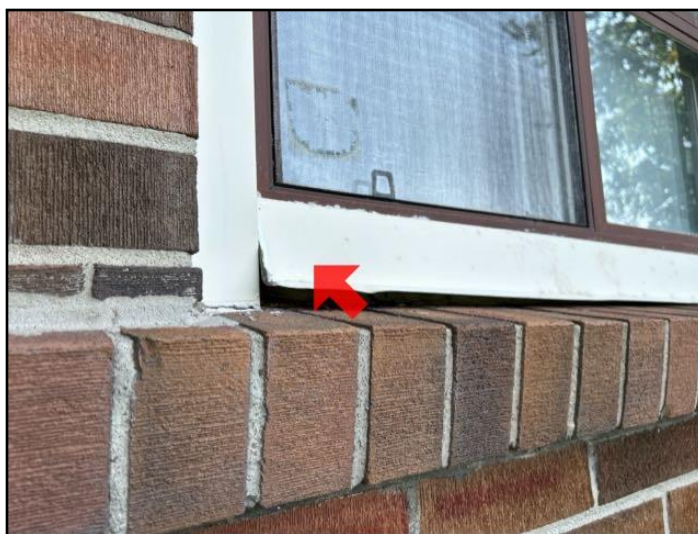
Condition: • [Missing or loose pieces](#)

Implication(s): Chance of water damage to structure, finishes and contents

Location: West

Loose pieces

Task: Repair

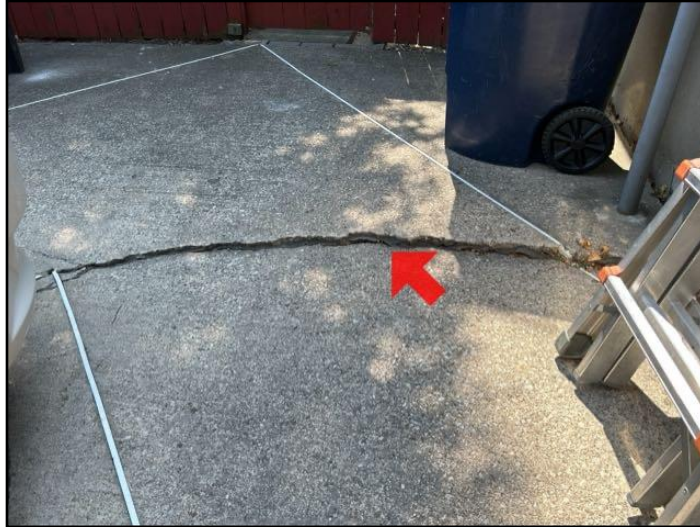
Condition: • [Uneven \(trip hazard\)](#)

Implication(s): Physical injury

Uneven (trip hazard)

Task: Repair

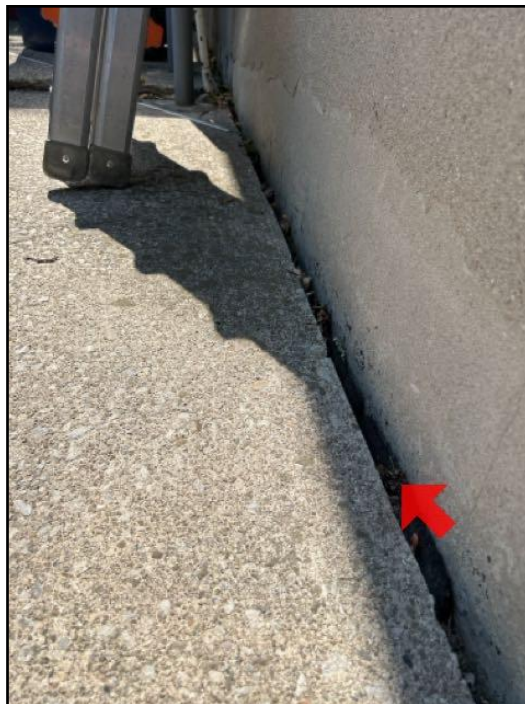
Condition: • [Unsealed gap at building](#)

Implication(s): Chance of water damage to structure, finishes and contents

Unsealed gap at building

Task: Repair

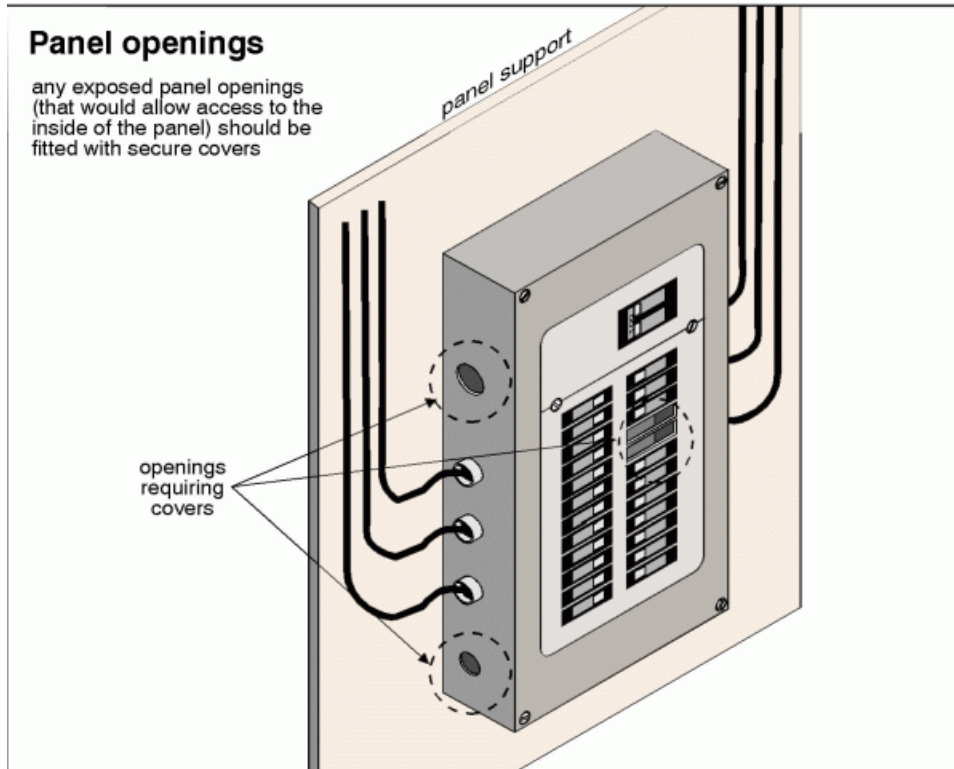
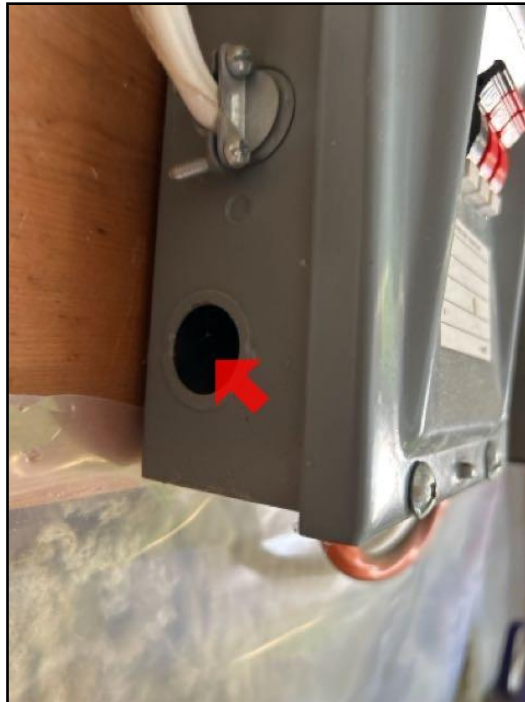
Condition: • [Openings in panel](#)

Implication(s): Electric shock | Fire hazard

Location: Garage

Openings in panel

Task: Repair

Seller reports this has been covered.

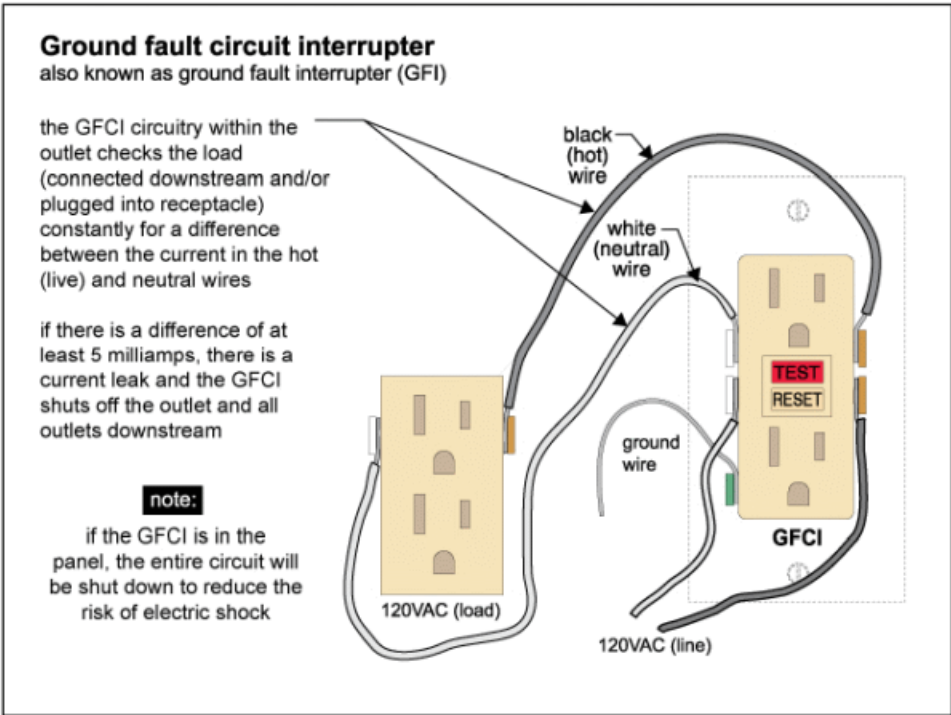
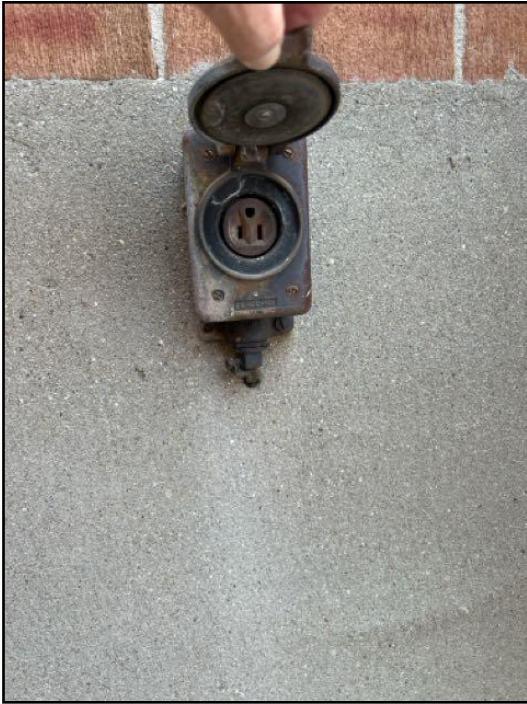
Condition: • [No GFCI/GFI \(Ground Fault Circuit Interrupter\)](#)

Implication(s): Electric shock

Location: East Exterior

No GFCI/GFI

Task: Provide

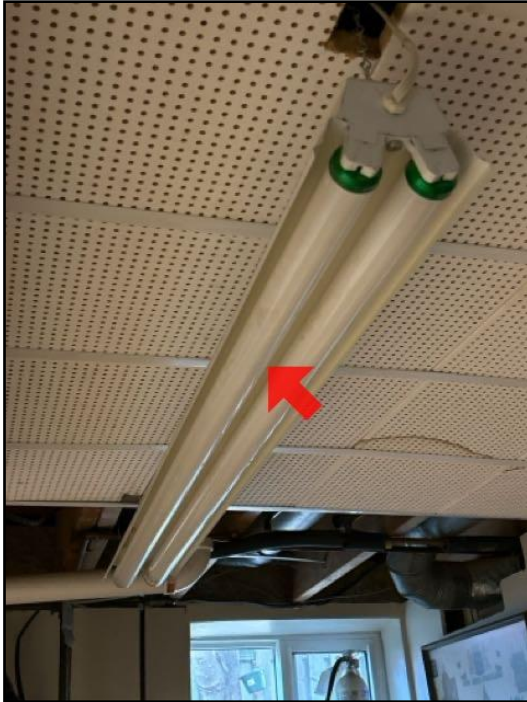
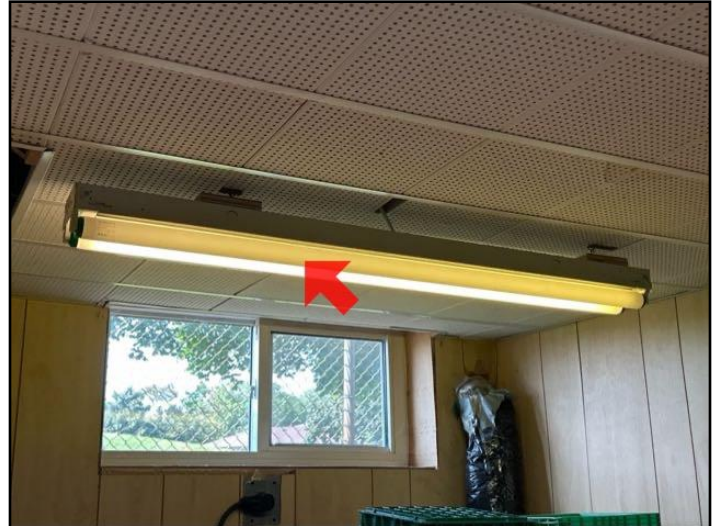
Condition: • Exposed to mechanical damage (No cage or protective lens)

Implication(s): Glass breaking | Physical injury

Location: Basement

Exposed to mechanical damage (No cage or...

Task: Repair or replace

Seller reports that ceiling has been replaced and new light bulbs installed.

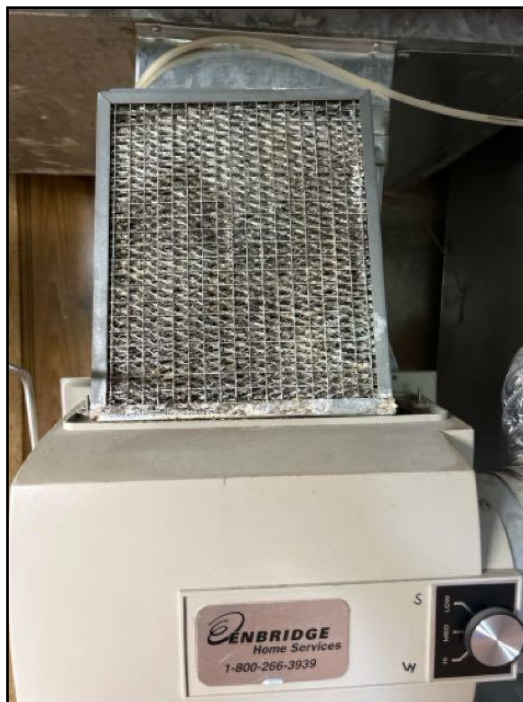
Condition: • Mesh pad dirty/clogged

Mesh pad dirty/clogged

Task: Replace

Seller has replaced the filter.

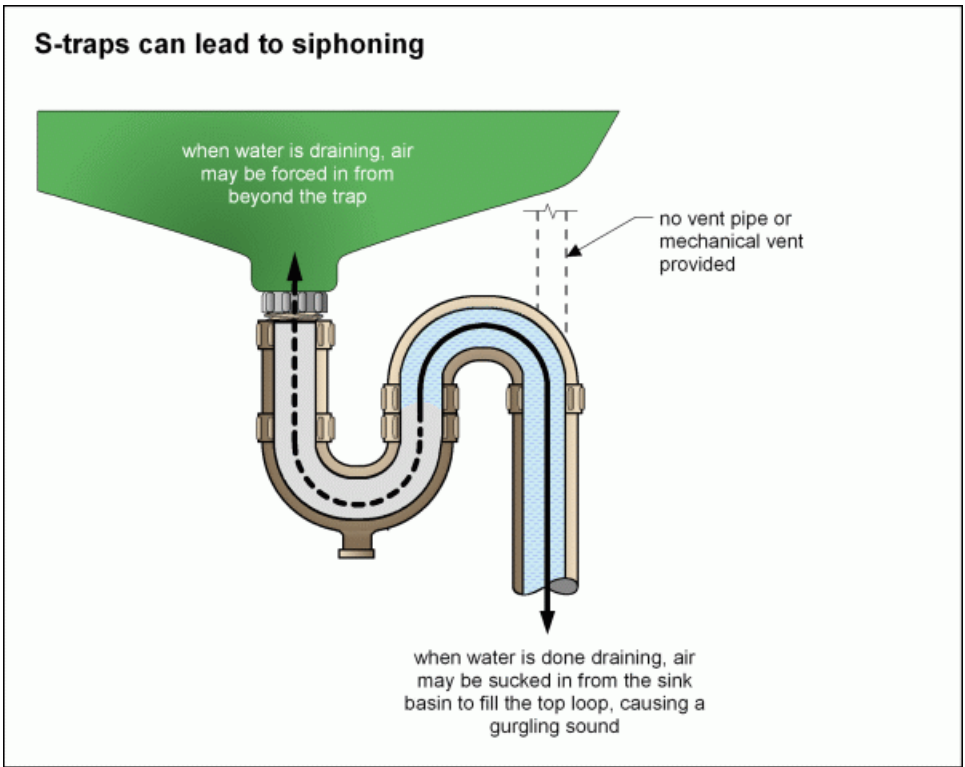
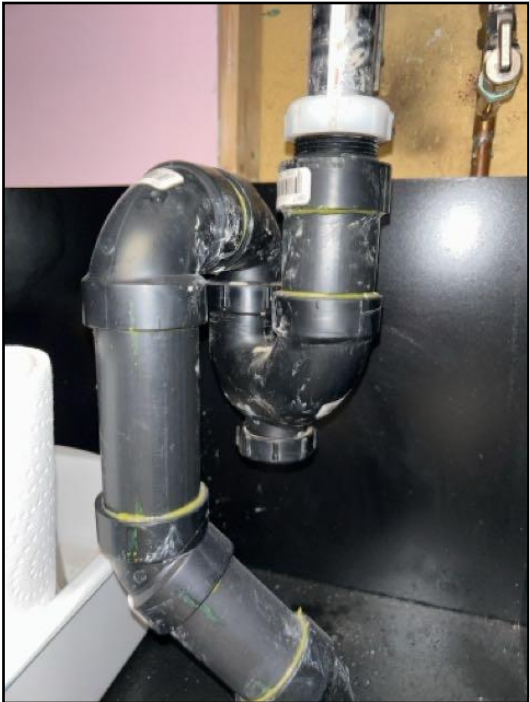
Condition: • [Nonstandard shape or material](#)

Implication(s): Reduced operability | Fixtures slow to drain

Location: Basement Powder Room

Nonstandard shape or material

Task: Improve

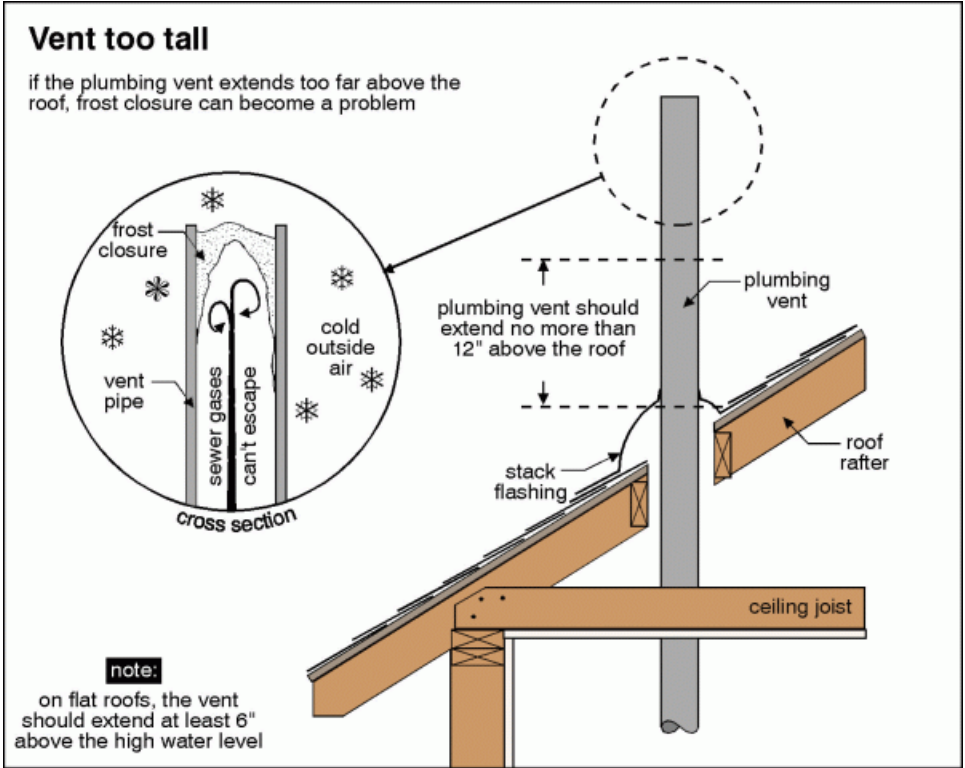
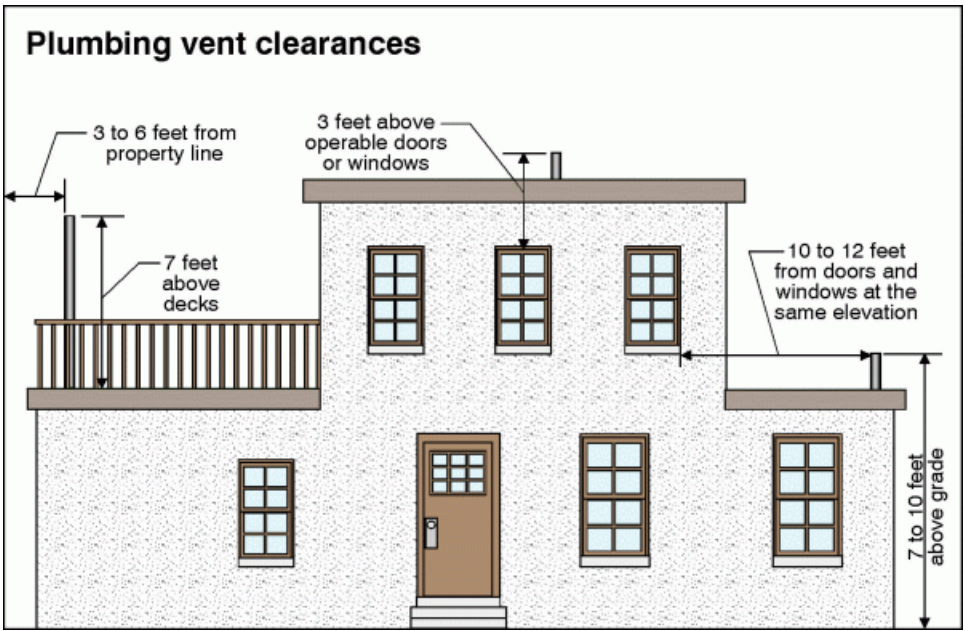
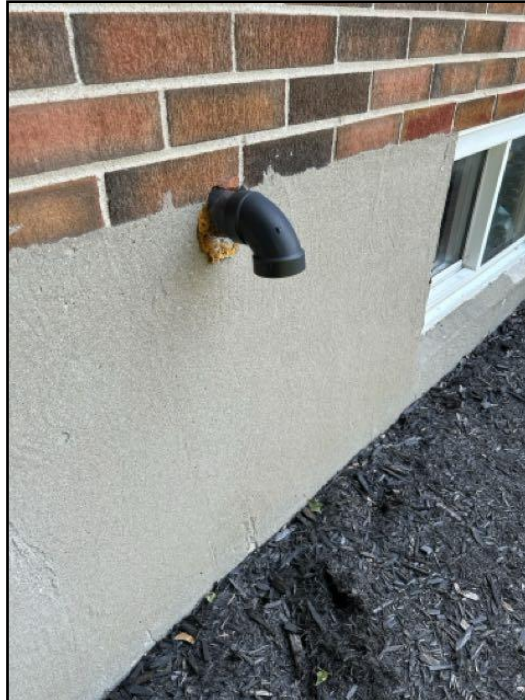
Condition: • [Vent termination problems](#)

Implication(s): Reduced operability | Sewer gases entering the building

Location: West Exterior
Task: Improve
Time: Less than 1 year
Cost: Minor

Vent termination problems

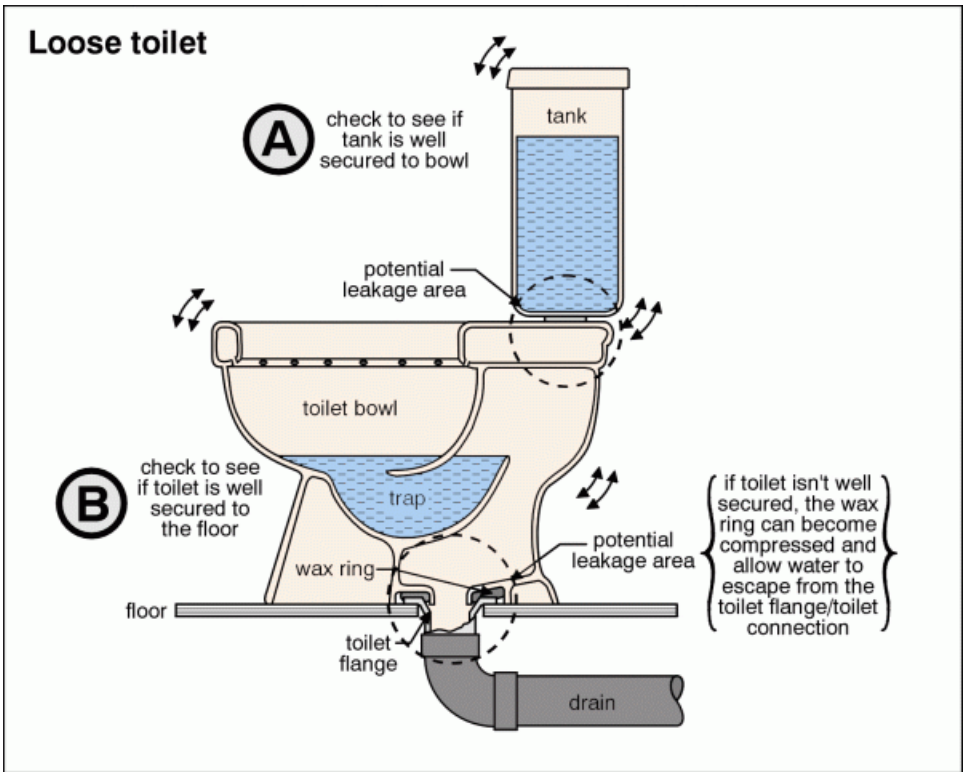
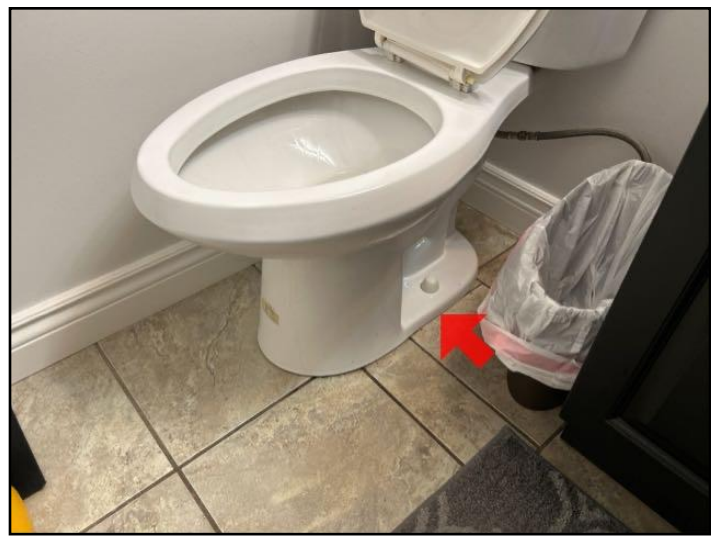
Condition: • [Loose](#)

Implication(s): Chance of water damage to structure, finishes and contents | Sewage entering the building | Possible hidden damage

Location: Basement Powder Room

Loose

Task: Repair

Seller reports this has been fixed.

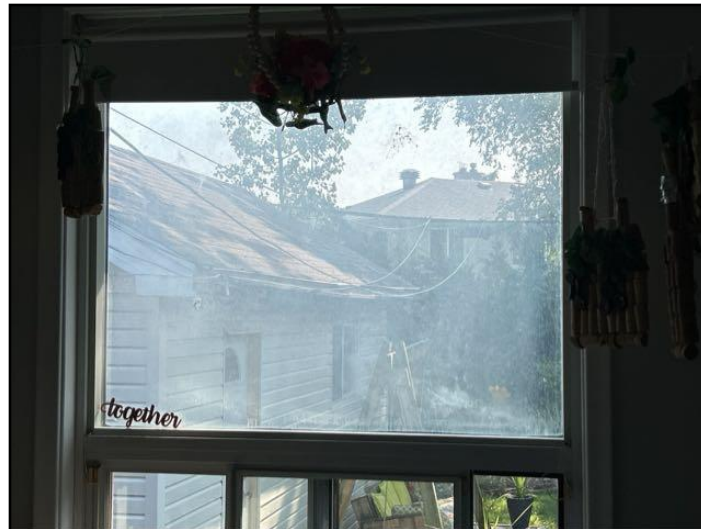
Condition: • [Lost seal on double or triple glazing](#)

Implication(s): Shortened life expectancy of material

Location: Various

Lost seal on double or triple glazing

Task: Repair or replace

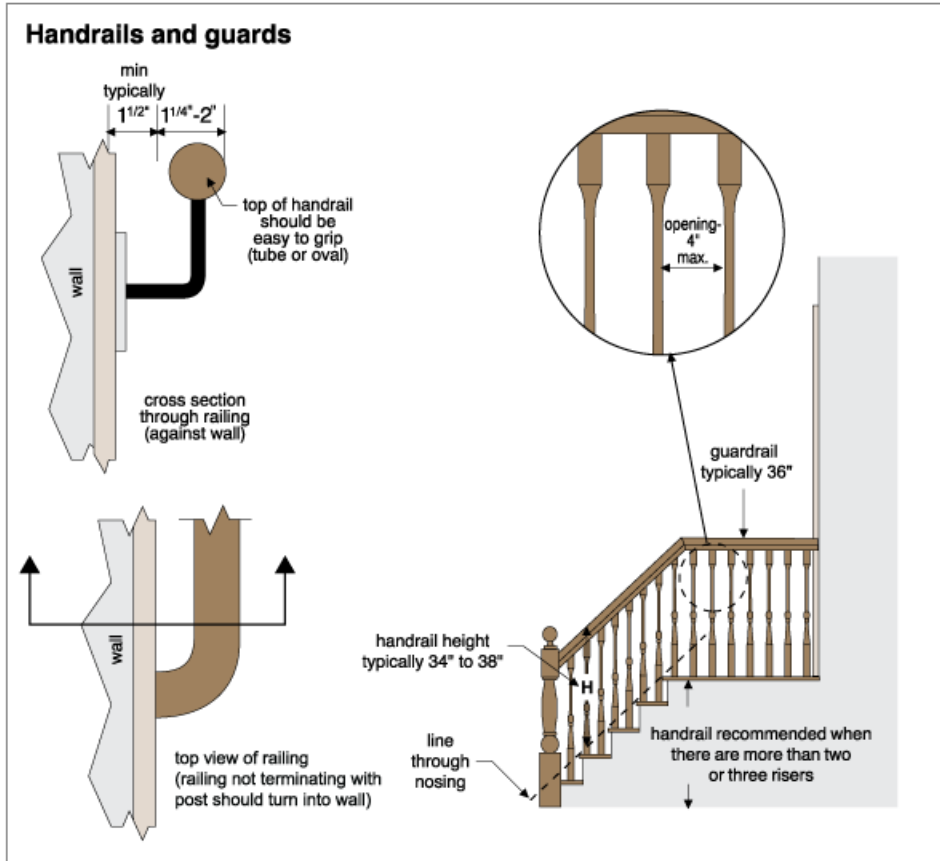
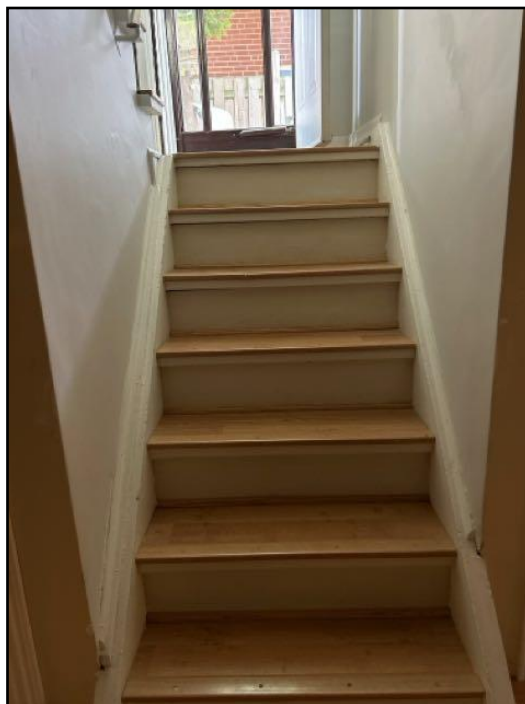
Condition: • [Missing](#)

Implication(s): Fall hazard

Location: Basement Staircase

Missing handrail

Task: Provide

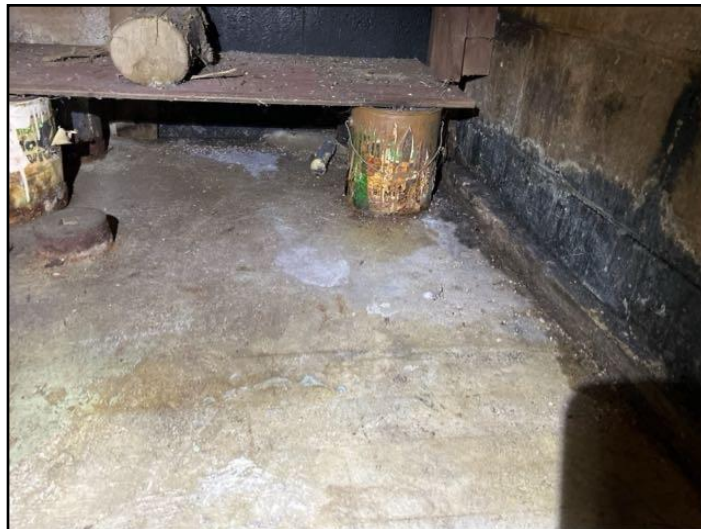
Condition: • Stains, damp - As reported by the sellers, there has been some water infiltration at the west end of the cold room during the most extreme rain events.

Location: Cold Room

Stains, damp

Task: Further evaluation
