Home Inspection Report

PROPERTY INSPECTED:
5 Gordon Park Drive
Toronto, ON M9B 1J5

Date of Inspection: 04/03/2024

Inspection No. 141465-887

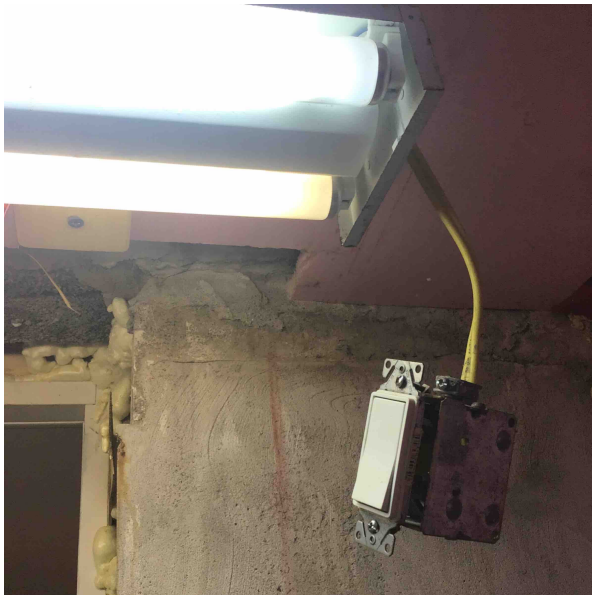
8.10.2 Loose switch(es) should be replaced for improved electric safety. **(Cold cellar)**

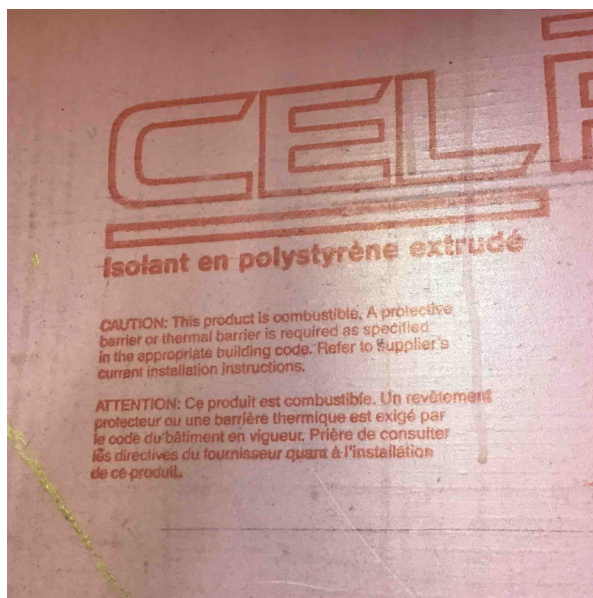
11.6.1 Exposed ISO / Rigid insulation requires a fire rated covering installed upon it for life safety (**Cold cellar**)

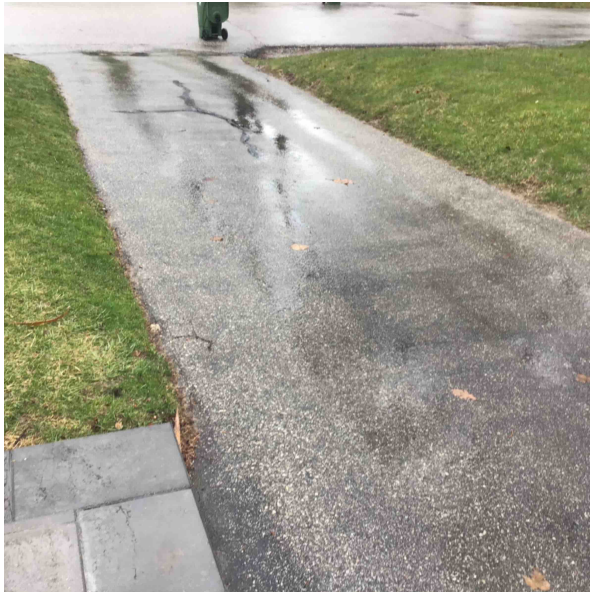
2.4.1 Minor settlement in traffic areas

2.4.2 The driveway shows typical and minor surface wear and cracking. Periodic maintenance may prolong the life of the surface.

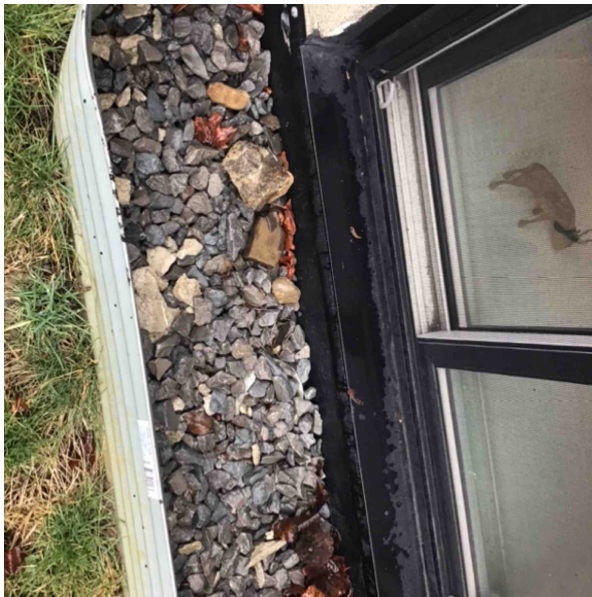
3.10.2 A basement bedroom window has been enlarged (**Exterior Right**)

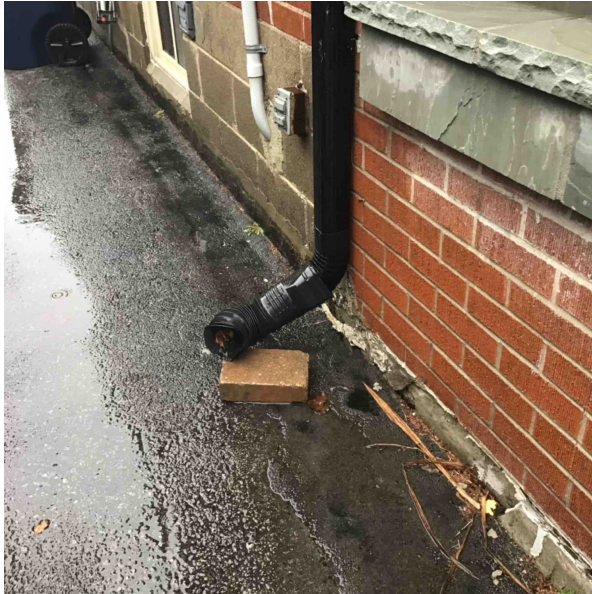
4.6.1 Downspouts discharge near base of foundation

4.6.3 The downspouts are not extended. Extend downspouts to limit water entry into the basement (**Exterior Left**)

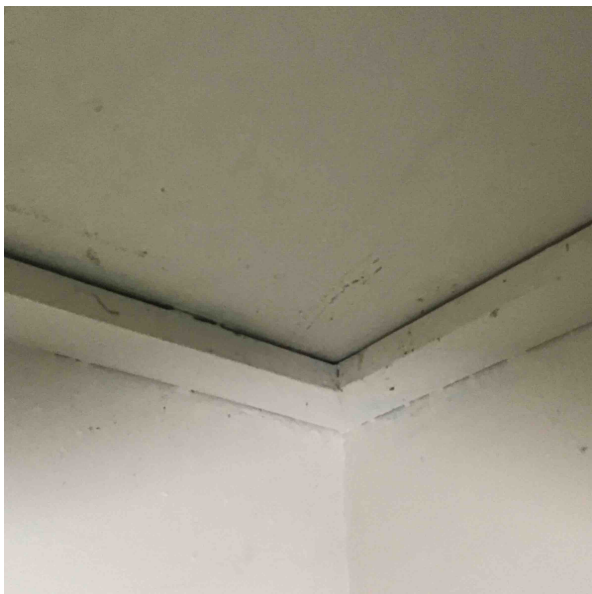
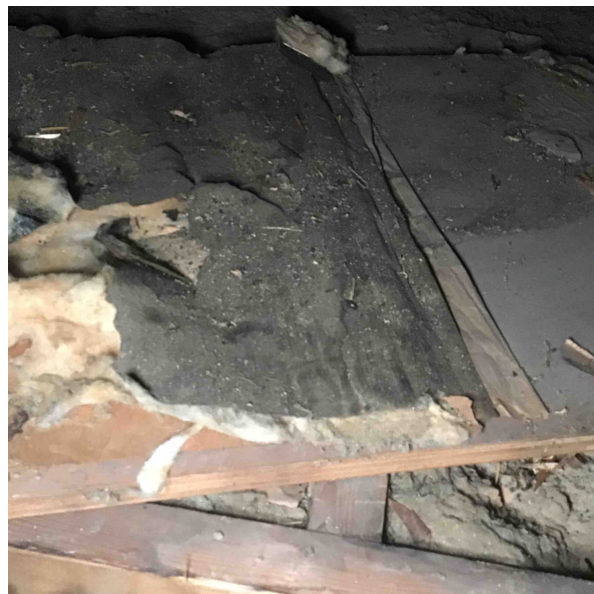
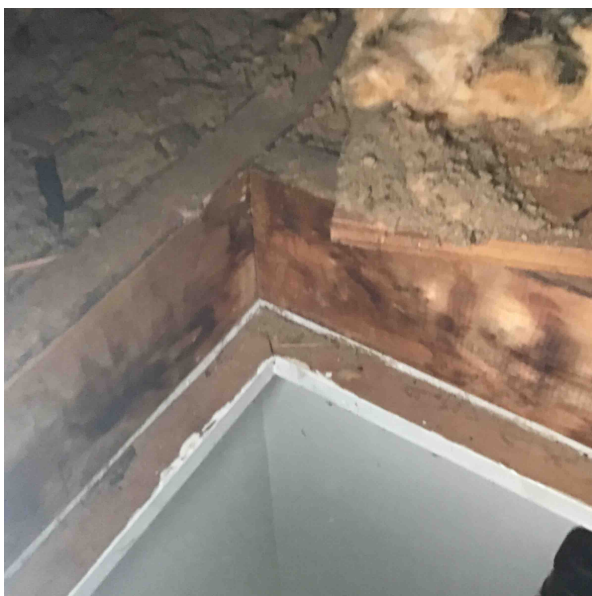
5.2.2 We suggest that the attic hatch have additional insulation applied for increased energy efficiency

The access hatch requires weather stripping to stop heat loss and transference of humidity into the attic (**Bedroom - Front Right**)

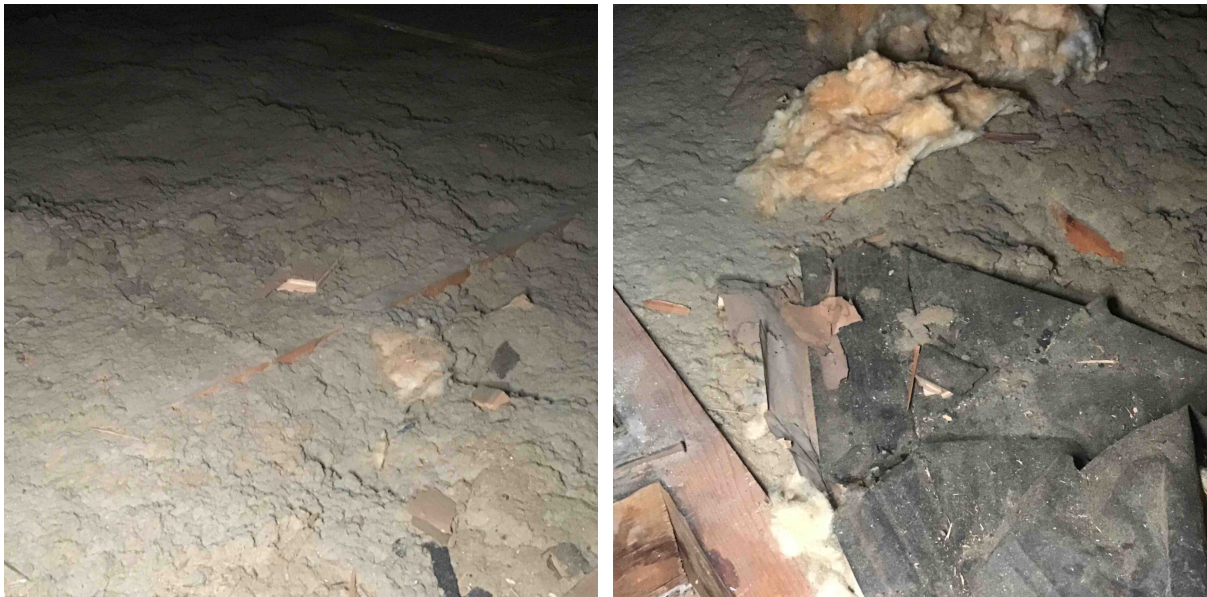
5.3.2 Provide additional insulation to improve energy efficiency.

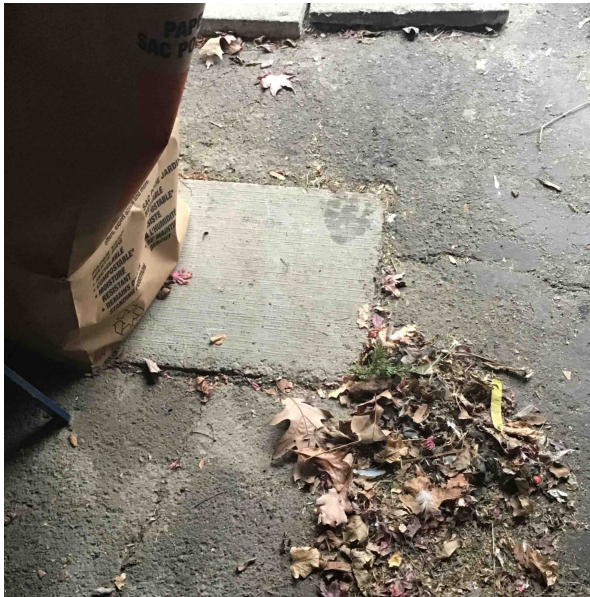
6.5.2 Typical minor floor cracks are present in the garage floor. No improvement is necessary at this time. **(Garage)**

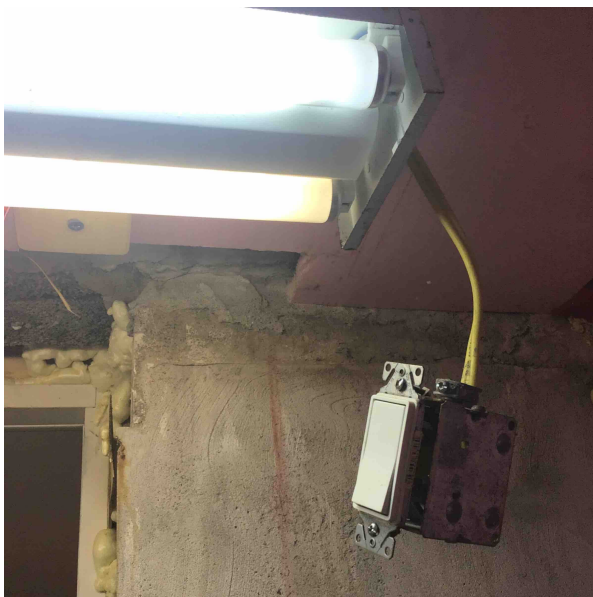
8.10.2 **Loose switch(es) should be replaced for improved electric safety. (Cold cellar)**

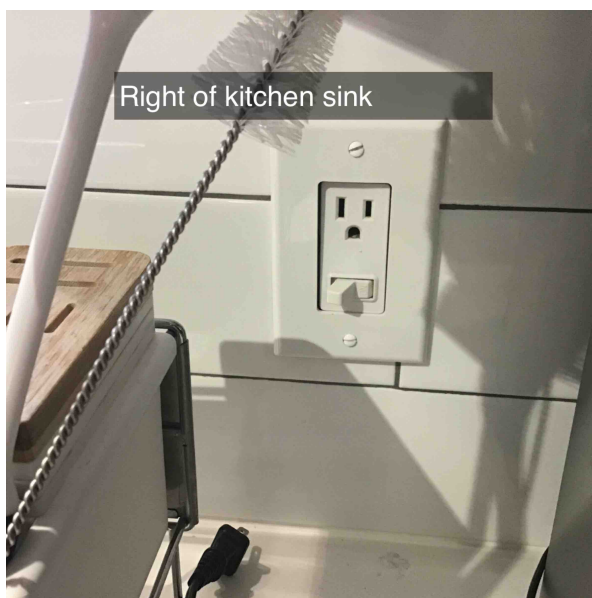
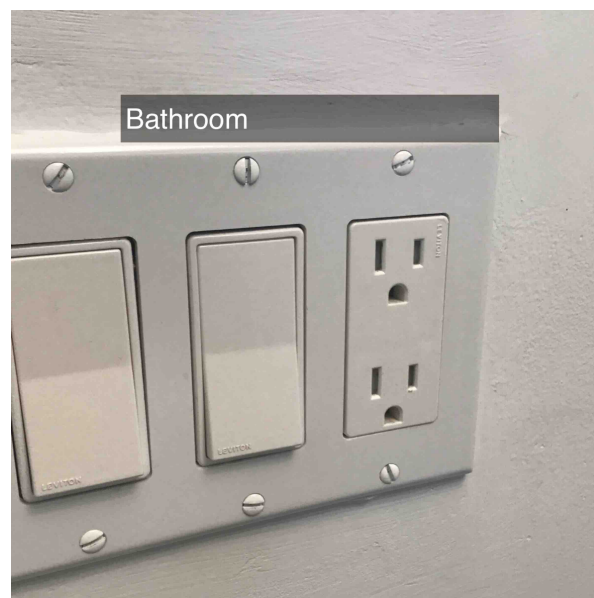
- Bathroom
- Kitchen

8.12.2 Install GFCI outlets for improved electric safety.

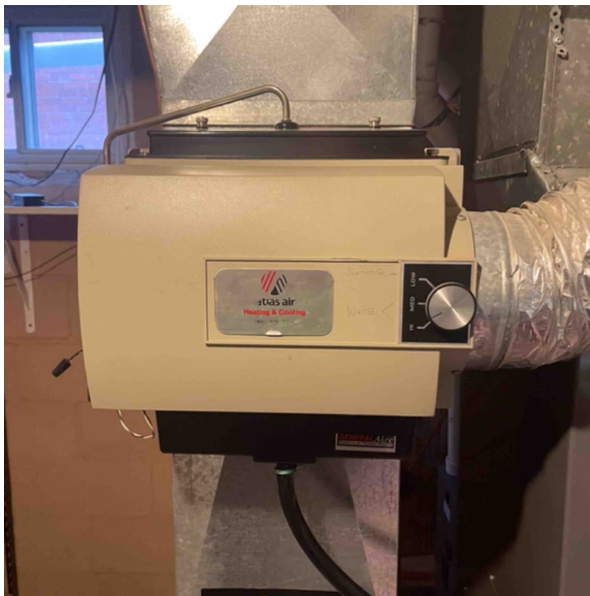
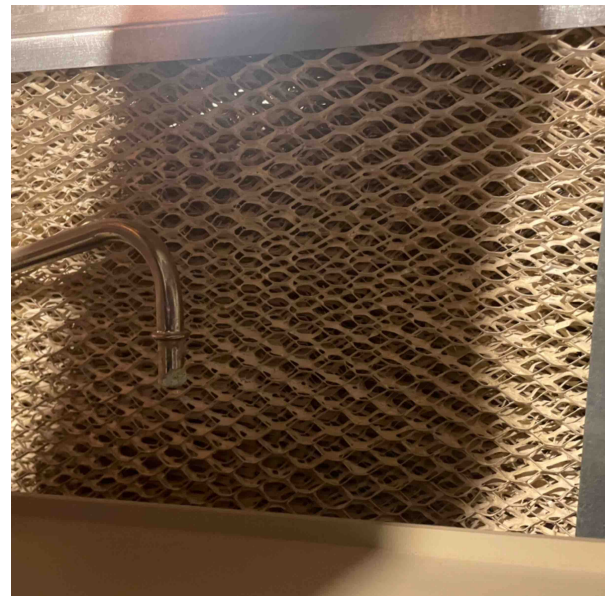
9.12.1 A humidifier is present, however the functionality was not determined. Have the unit assessed by an HVAC technician during annual servicing.

9.12.2 We would suggest cleaning and descaling the humidifier yearly at the start of the heating season. Replace evaporator pad / trickle assembly required. **(Mechanical Room / Utility Room)**

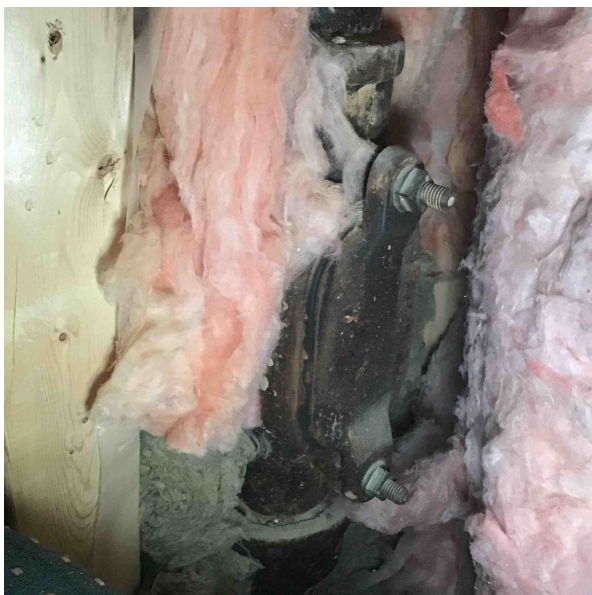
10.4.2 The drain, waste and vent piping is cast iron. A qualified plumber should further assess and upgrade / replace as required to prevent water damage due to cracking / corroding / pipe failure. Replacement may also be required by your insurance company for coverage. **(Storage room)**

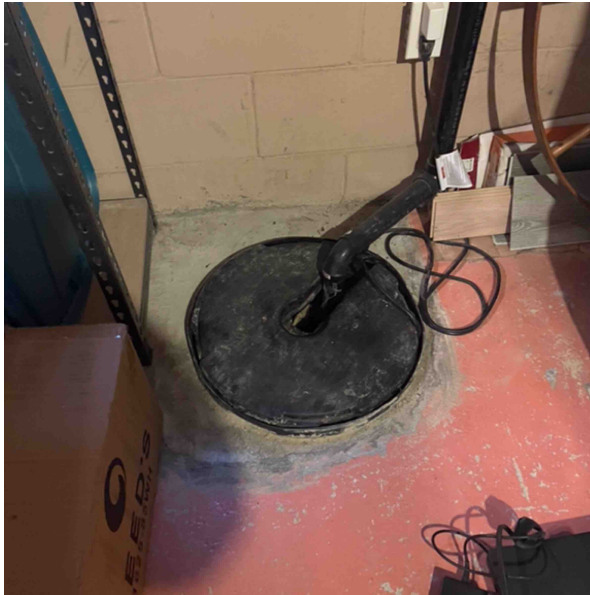
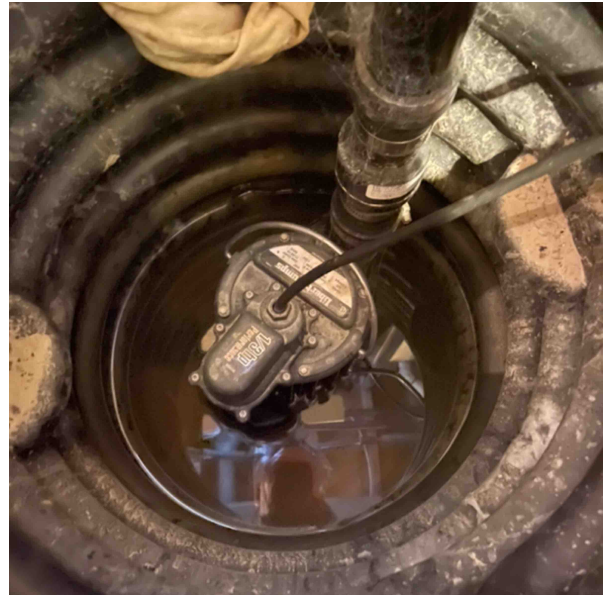
10.13.2 A battery backup / high water alarm for the sump pump is not present. Install a battery backup / high water alarm to ensure proper function in the event of a mechanical failure or power outage.

The sump pump check valve is missing. A qualified plumber should install a check valve for intended drainage function. **(Mechanical Room / Utility Room)**

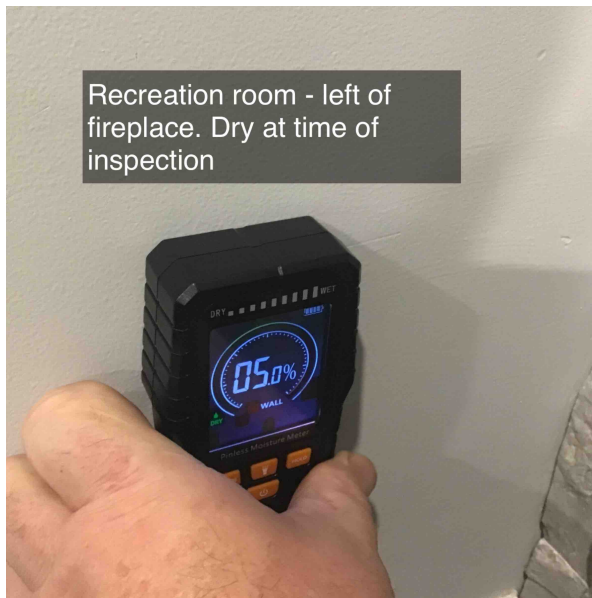
Recreation room - left of fireplace. Dry at time of inspection

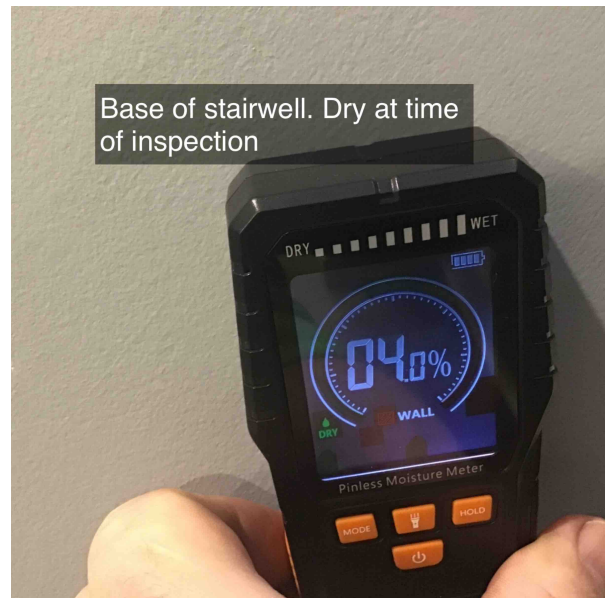
Base of stairwell. Dry at time of inspection

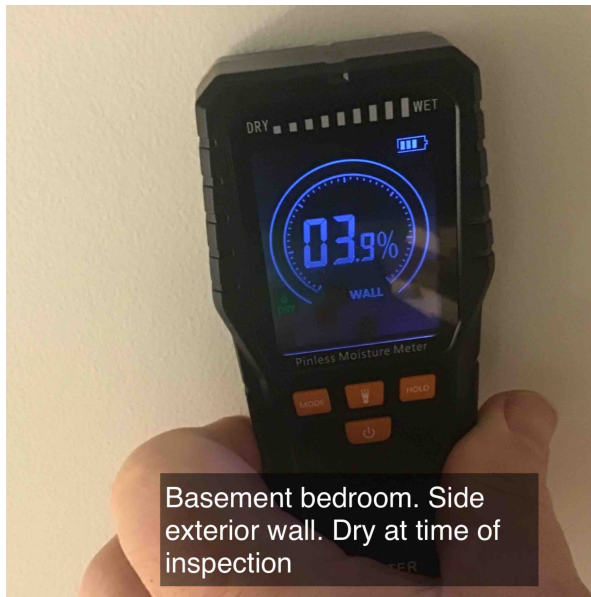
Basement bedroom. Side exterior wall. Dry at time of inspection

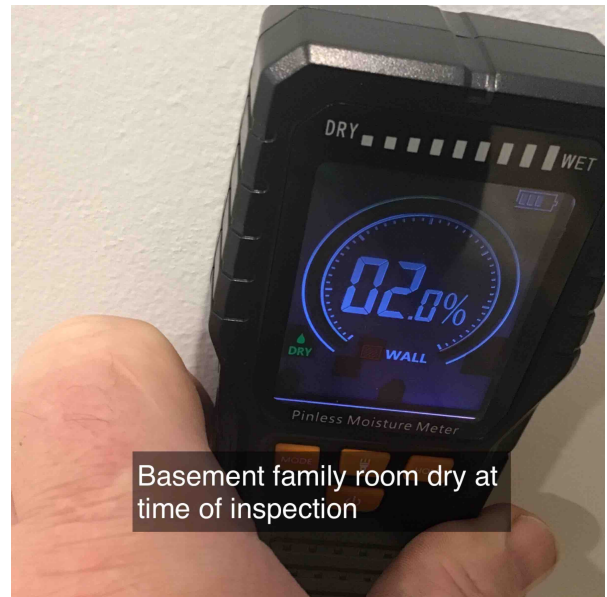
Basement family room dry at time of inspection

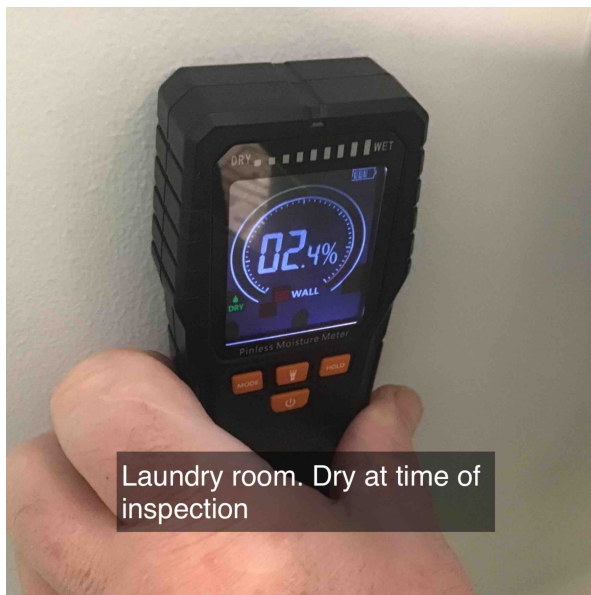
Laundry room. Dry at time of inspection

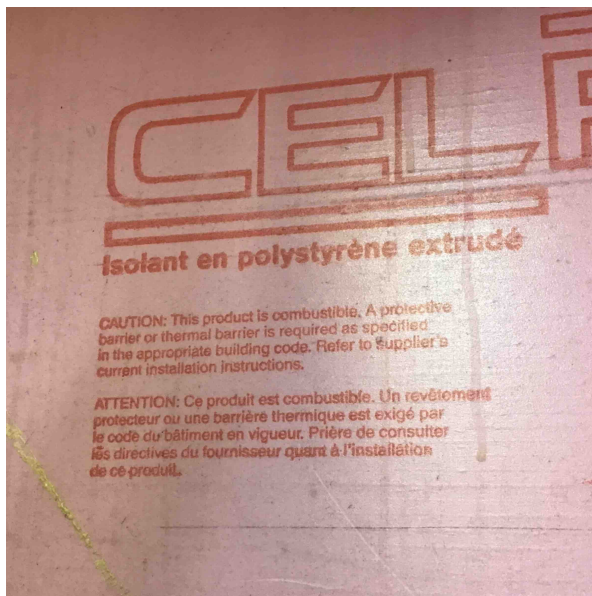
11.6.1 **Exposed ISO / Rigid insulation requires a fire rated covering installed upon it for life safety (Cold cellar)**
