Your Inspection Report

5 Risdon Court
Toronto, ON M9C 4E6

INSPECTION DATE:
Wednesday, April 10, 2024

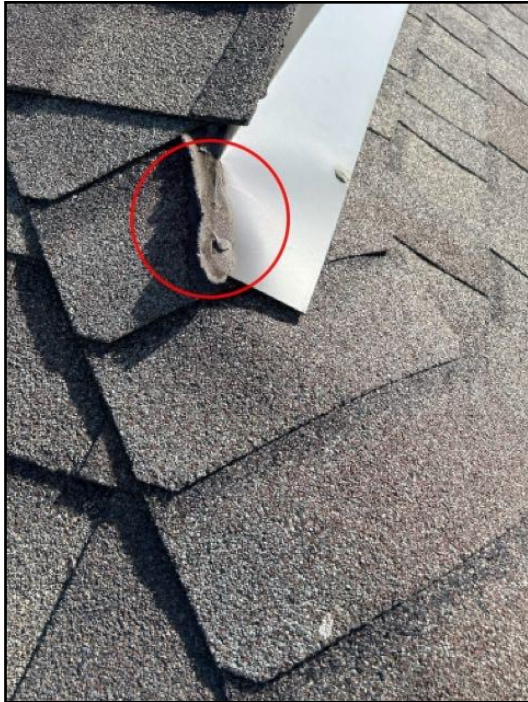
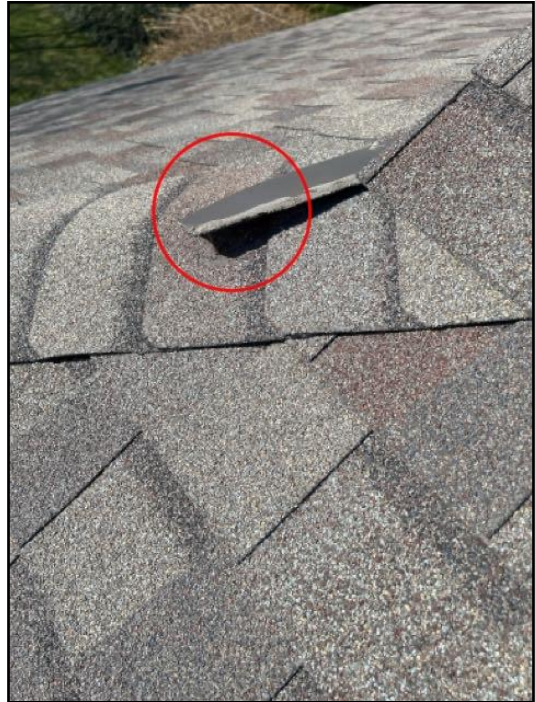
- Condition:** • Loose
- Location:** North, South
- Task:** Repair
- Time:** Less than 1 year
- Cost:** Minor

Loose flashing

Repaired, as per Estate Trustees.

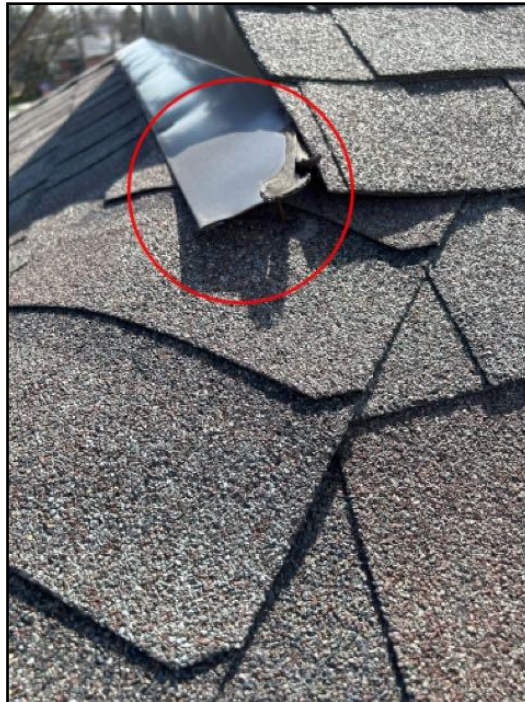
Loose flashing

Repaired, as per Estate Trustees.

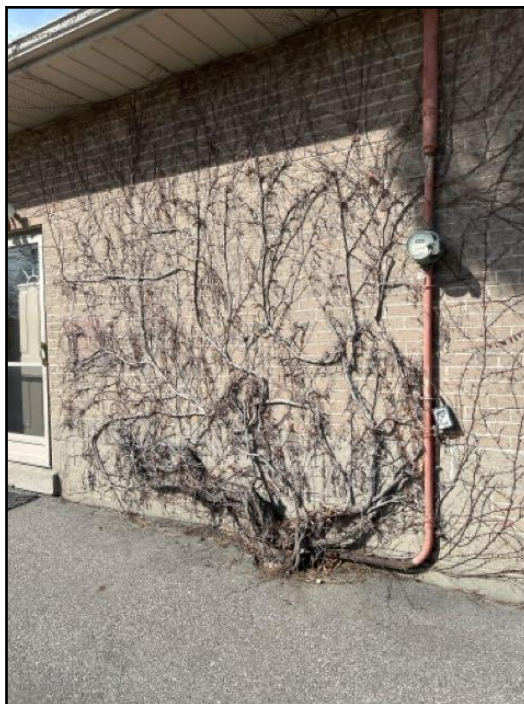
Condition: • Vines - over the long term vines can damage house walls.

Location: Northeast

Task: Remove

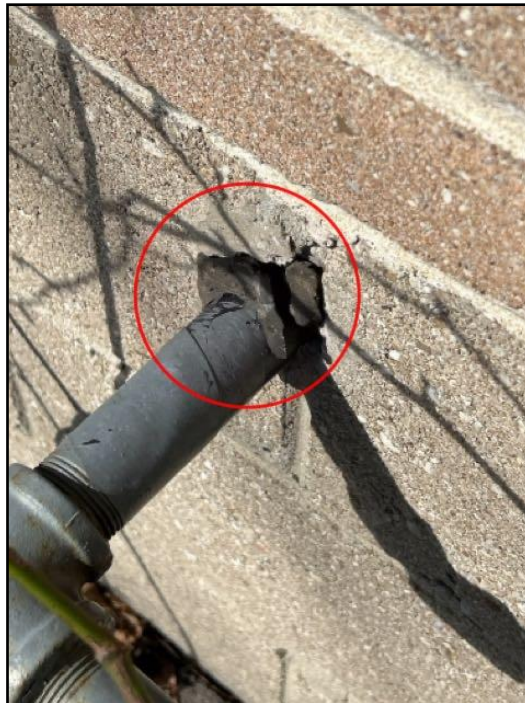
Condition: • [Caulking missing or ineffective](#)

Implication(s): Chance of water damage to structure, finishes and contents

Caulking ineffective

Repaired, as per Estate Trustees.

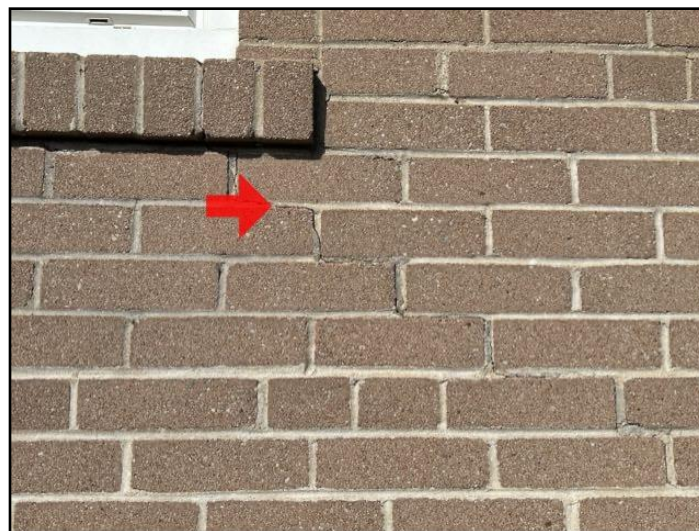
Condition: • Typical minor cracks

It is not uncommon to find small cracks near openings (doors and windows) in brick walls. These are not a structural concern.

Typical minor cracks

Task: Monitor

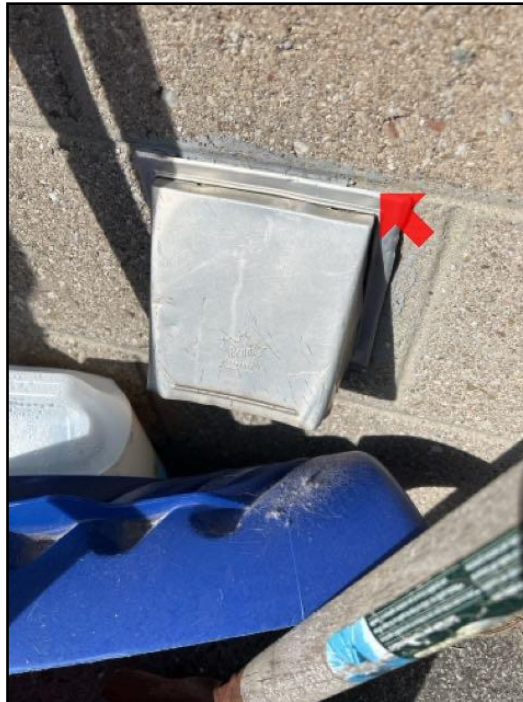
Condition: • Caulking deteriorated/missing

Caulking deteriorated/missing

**Repaired, as per
Estate Trustees.**

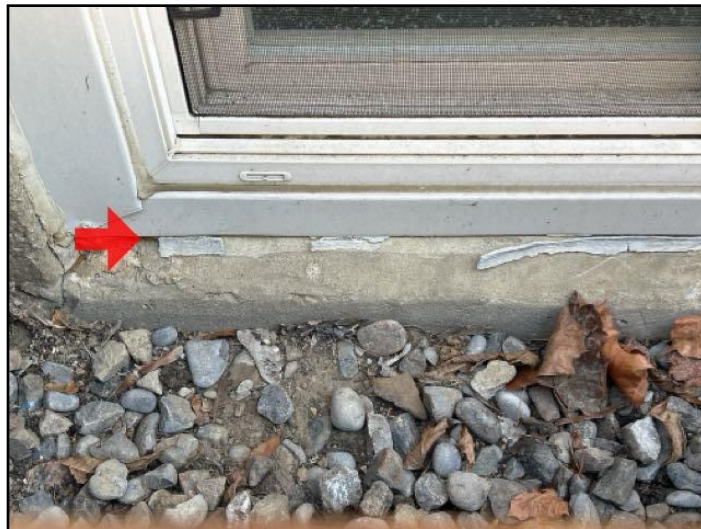
Condition: • [Caulking missing, loose or deteriorated](#)

Implication(s): Chance of water damage to structure, finishes and contents

Caulking missing, loose or deteriorated

Repaired, as per Estate Trustees.

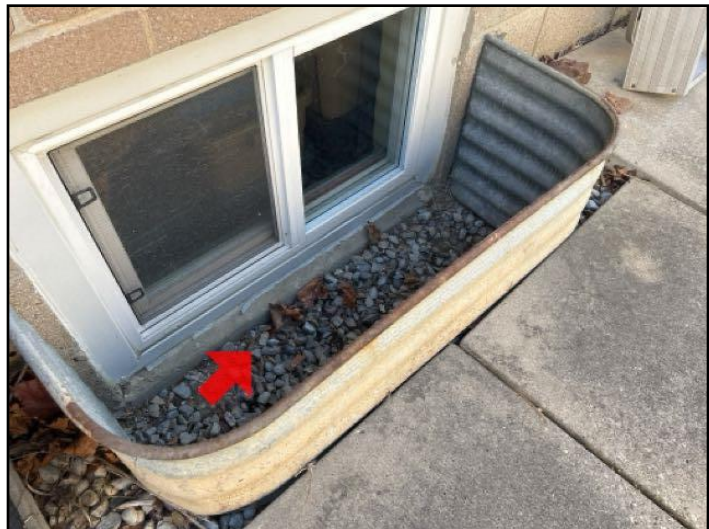
Condition: • [Less than 6 inches below window](#)

Implication(s): Chance of water entering building

Less than 6 inches below window

Task: Improve

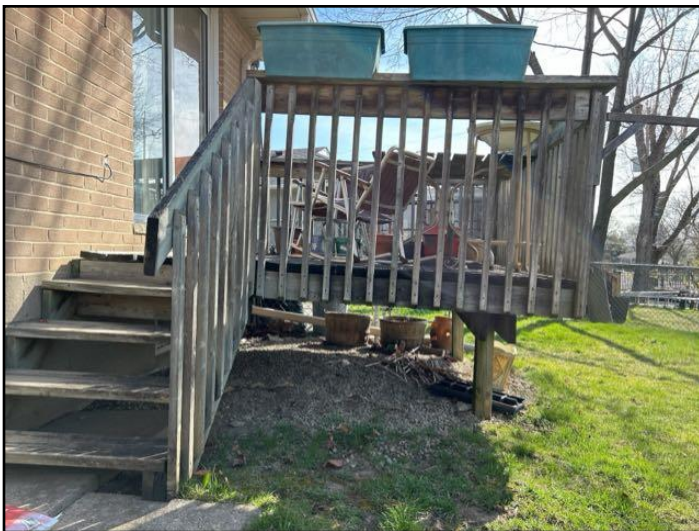
Condition: • Disrepair

Columns settled, poor connection of beam to columns (currently side-nailed, should bear on top of posts)

Settled

Task: Repair or replace

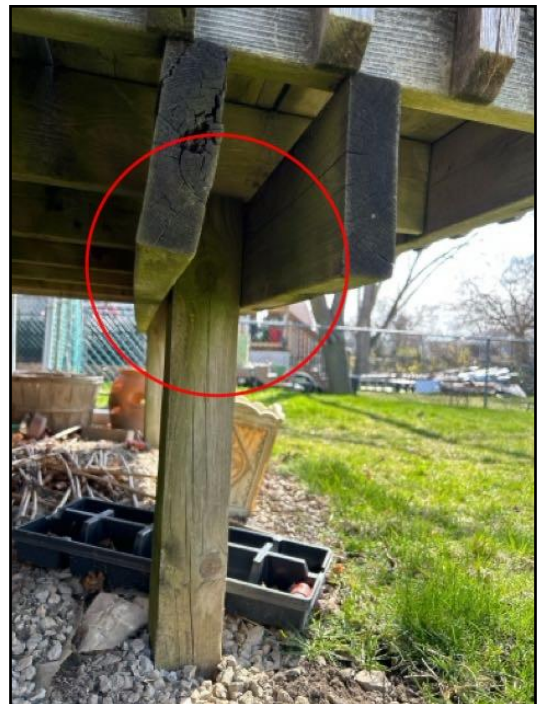
Poor connection/bearing

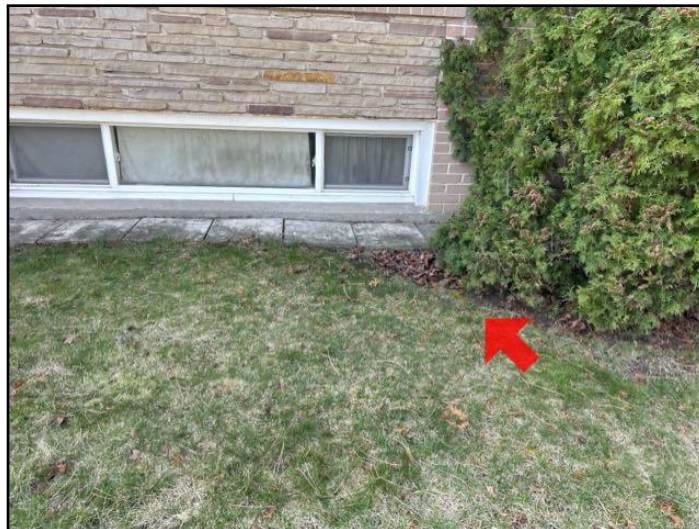
Condition: • [Improper slope or drainage](#)

There have been recent heavy rains and there is no evidence of interior water issues. If making landscape changes, seek to improve the grading to take water away from the building.

Improper slope or drainage

Task: Improve

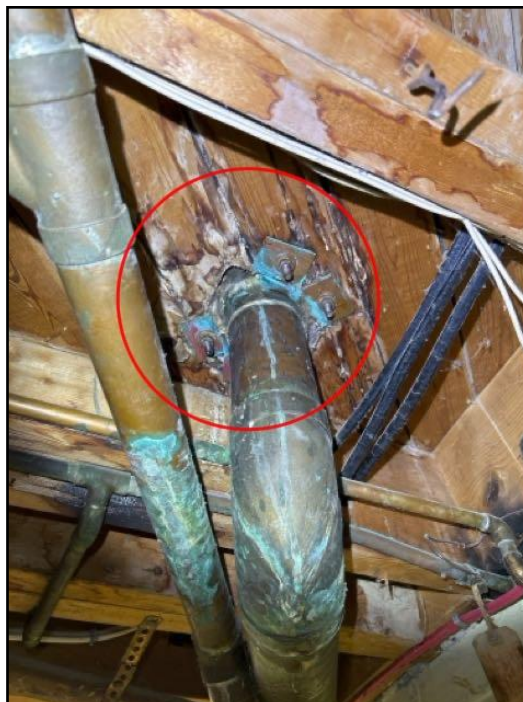
Condition: • Rot

There has been some long term leaking around the toilet, resulting in rot in the sub floor. Photo taken from the basement under the toilet.

Rot

Repaired, as per Estate Trustees.

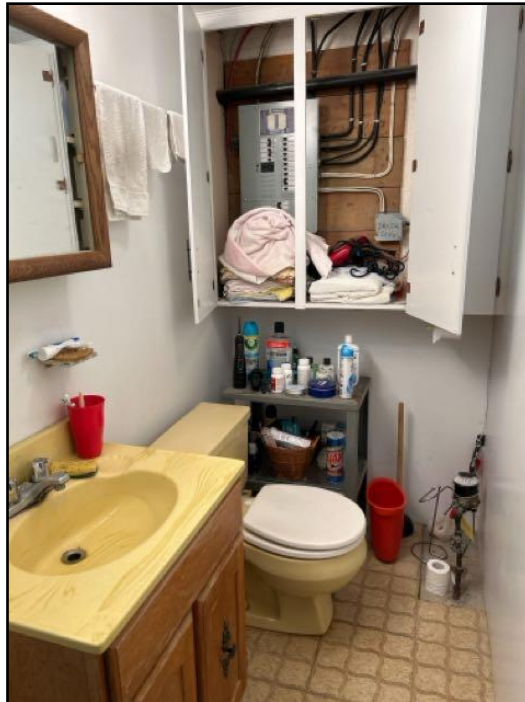
Condition: • [Poor location](#)

Electric panels should not be located in bathrooms. If adding a shower or bathtub, this issue will need addressing. Also toilet interferes with panel access.

Poor location for panel

Task: Correct

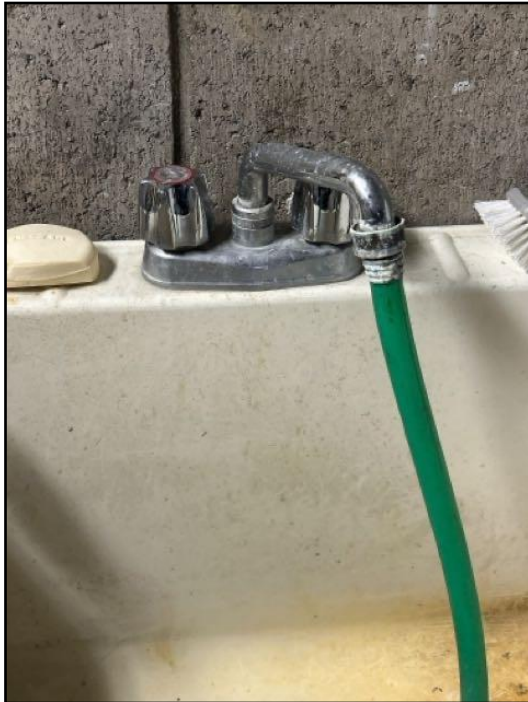
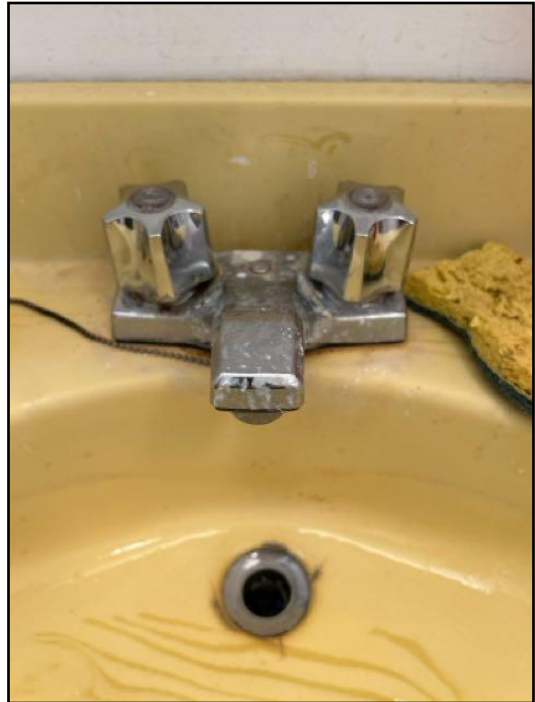
Condition: • [Drip, leak](#)

In both cases the drips are hot water. This can increase energy costs.

Drip, leak

Task: Replace

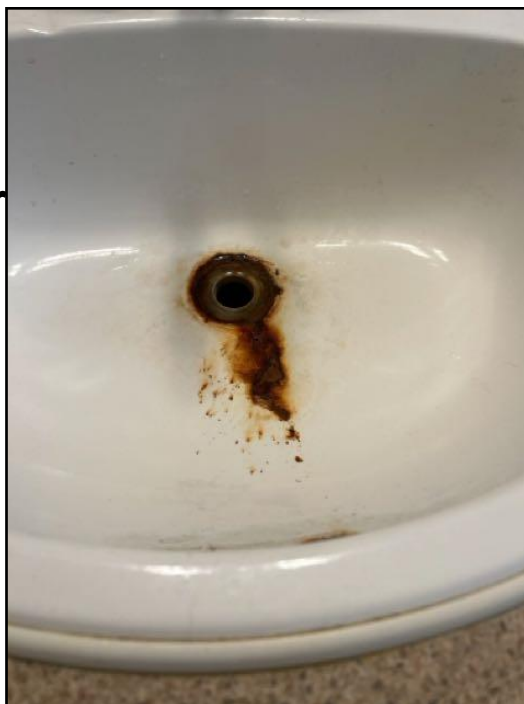
Condition: • [Rust](#)

Rust

Repaired, as per Estate Trustees.

Sink replaced, as per Estate Trustees.

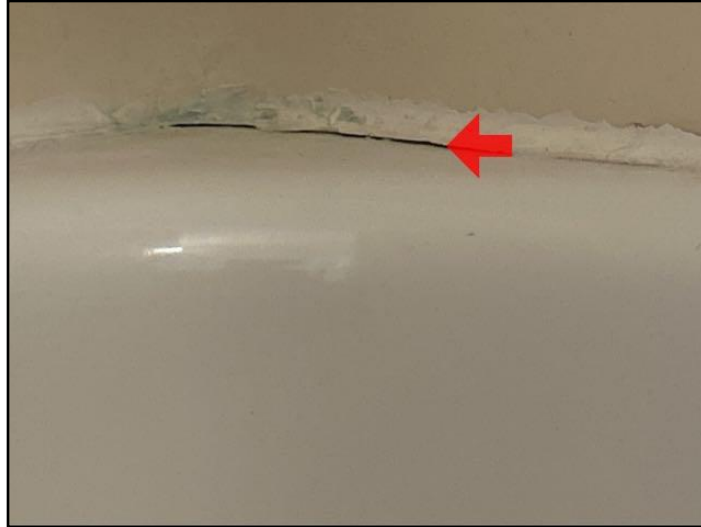
Condition: • [Caulking loose, missing or deteriorated](#)

Caulking loose, missing or deteriorated

Repaired, as per Estate Trustees.

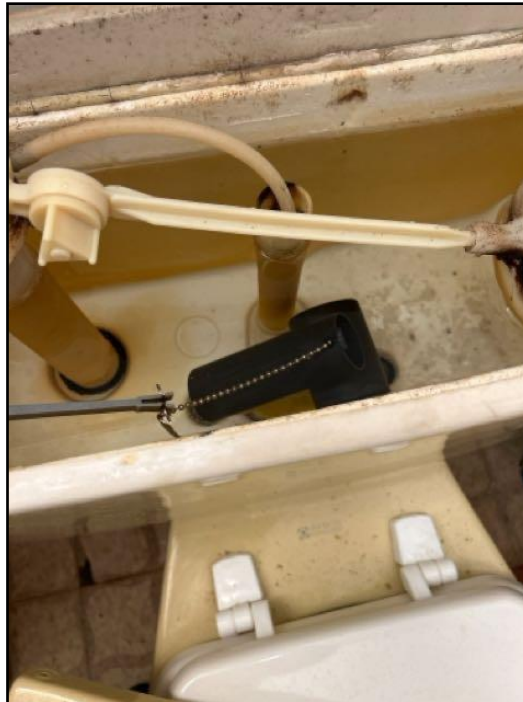
Condition: • [Obstructed or weak flush](#)

Obstructed or weak flush

Adjust flush handle and/or chain length

Repaired, as per Estate Trustees.

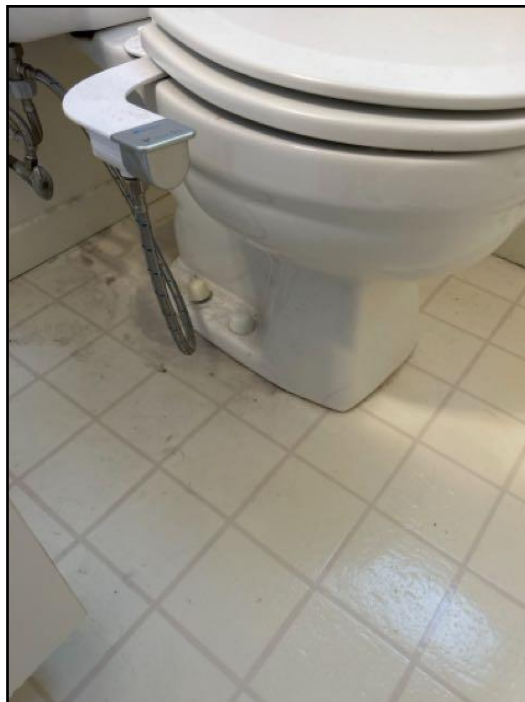
Condition: • [Loose](#)

Loose toilet appears to be due to rot in the subfloor - see Structure section.

Loose

Repaired, as per Estate Trustees.

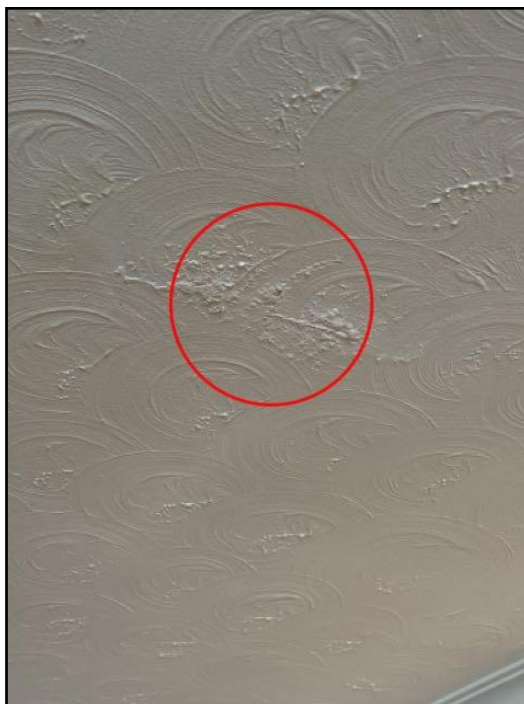
Condition: • [Water damage](#)

There is a small area of efflorescence on the dining room ceiling. This is likely due to an old issue that pre-dates the current roof as there have been recent heavy rains the area tests dry with a moisture meter.

Efflorescenece

Task: Repair

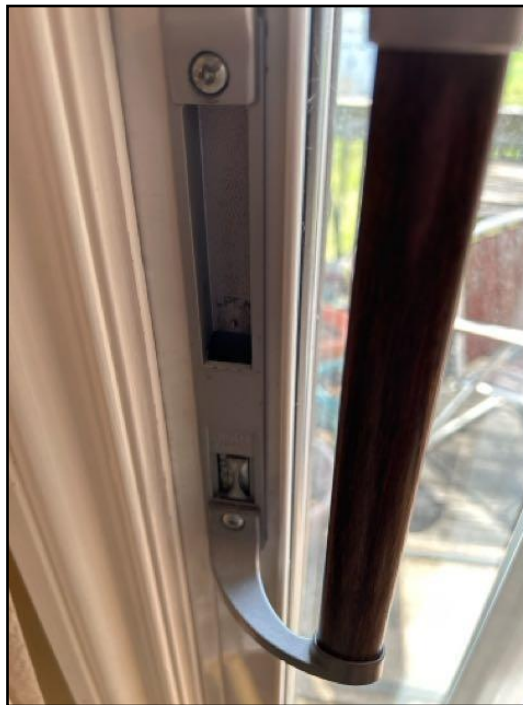
Condition: • [Broken](#)

Lock mechanism missing or broken. Jimmy bars are a more effective security measure for sliding glass doors.

Broken

Task: Repair or replace
