Your Inspection Report

6 Leonard Street, Suite 16
Richmond Hill, ON L4C 0L6

INSPECTION DATE:
Tuesday, February 18, 2025

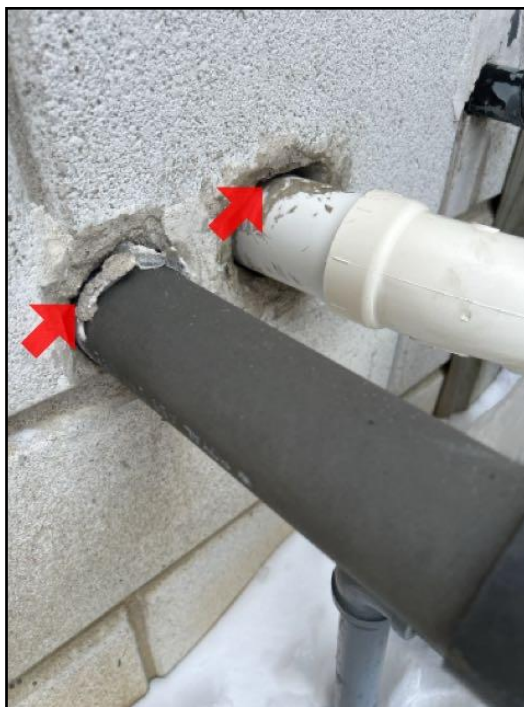
Condition: • Caulking deteriorated/missing

Location: Rear

Caulking deteriorated/missing

Task: Repair

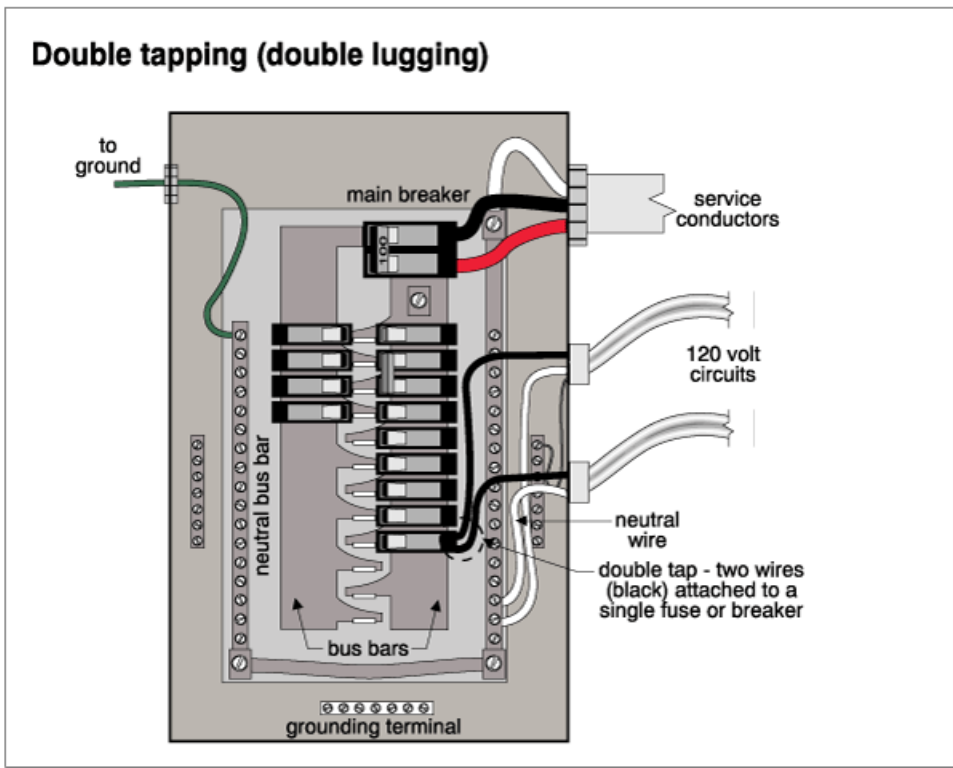
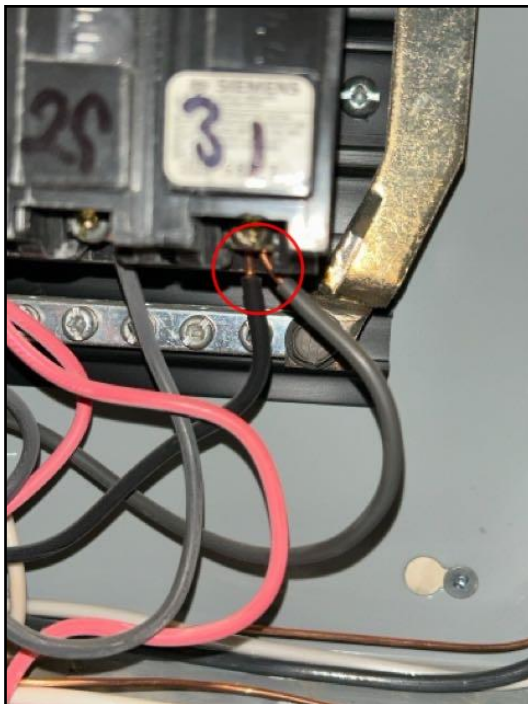
Condition: • [Double taps](#)

Implication(s): Fire hazard

Double taps

Task: Correct

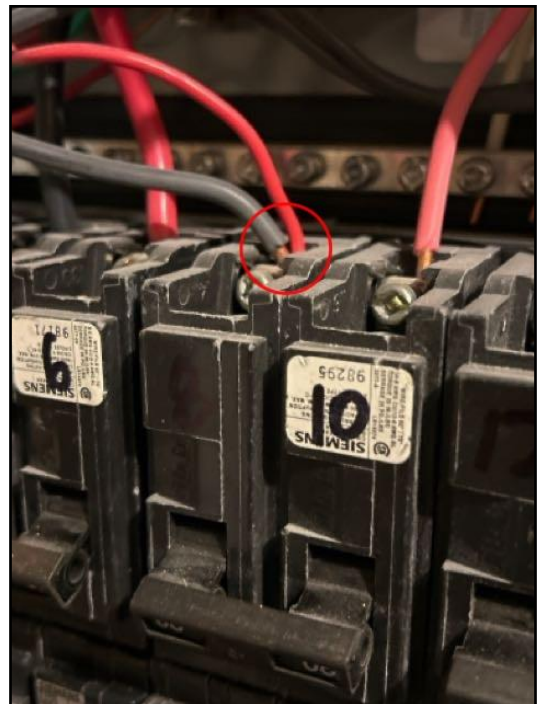
Double taps

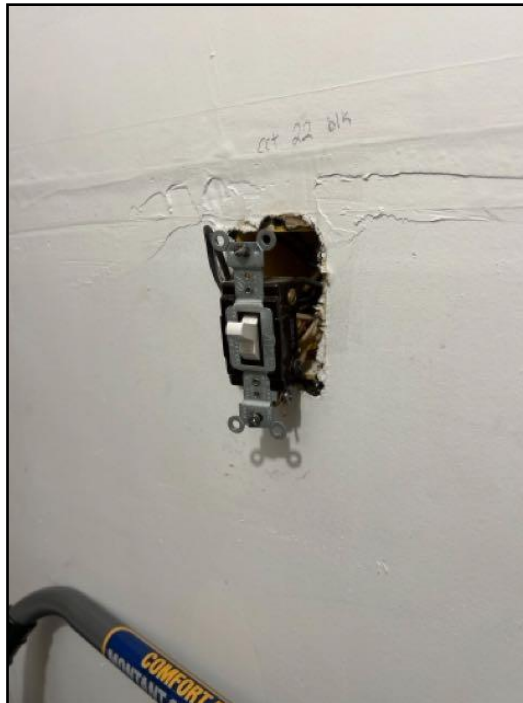
Condition: • Loose, missing cover plate

Location: Garage Storage Closet

Loose, missing cover plate

Task: Improve
Time: Immediate
Cost: Minor

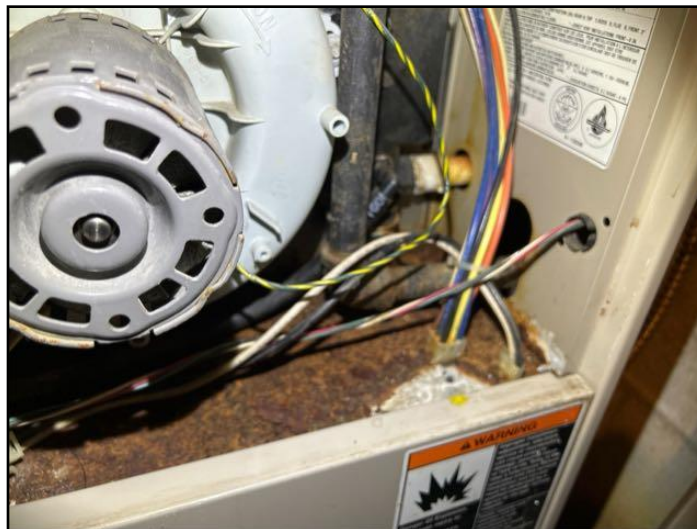
Condition: • [Rust](#)

Rust in the cabinet is dry. It must either be due to an old furnace condensate issue that has been repaired or it could be due to a current or already repaired issue with the condensate drainage from the air conditioning system (which cannot be investigated until cooling season).

Implication(s): Material deterioration | Reduced system life expectancy

Rust in cabinet

Task: Further evaluation

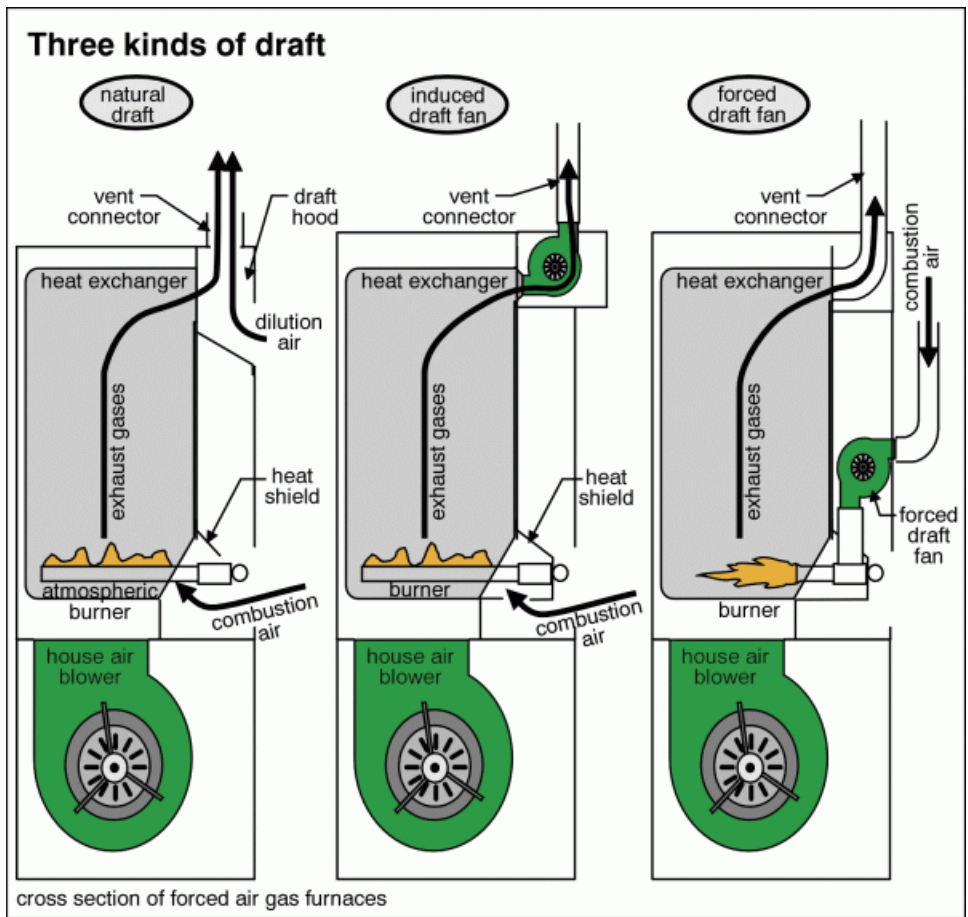
Condition: • [Induced draft fan problems](#)

Noisy draft fan may indicate it is near end of service.

Implications: Risk of equipment failure, no heat

Task: Further evaluation

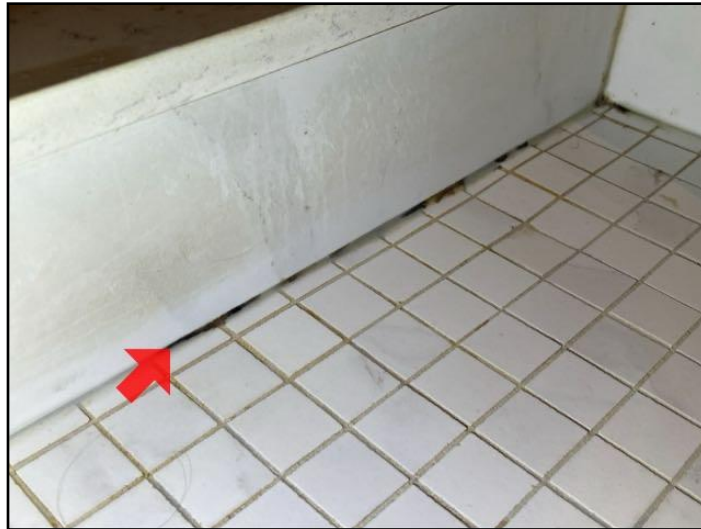
- FIXTURES AND FAUCETS \ Shower stall**
- Condition: • [Caulking loose, missing or deteriorated](#)
- Implication(s): Chance of water damage to structure, finishes and contents
- Location: Principal Ensuite Bathroom
- Task: Repair
- Time: Less than 1 year
- Cost: Minor

Caulking loose or deteriorated

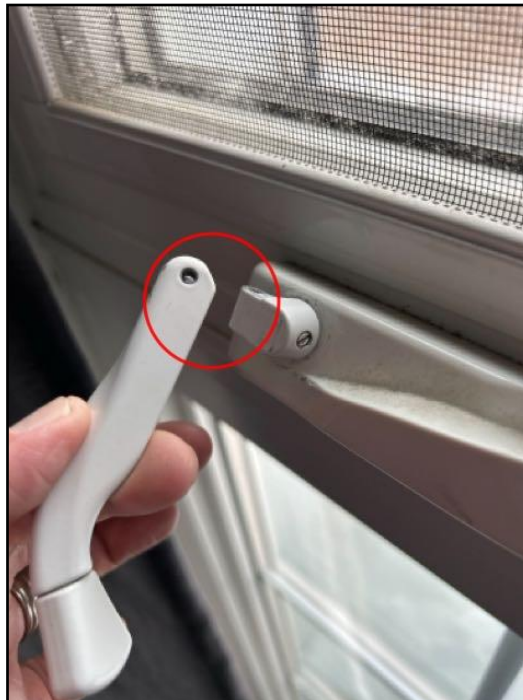
Condition: • [Broken](#)

Implication(s): System inoperative or difficult to operate

Location: Rear Third Floor Bedroom

Broken

Task: Repair

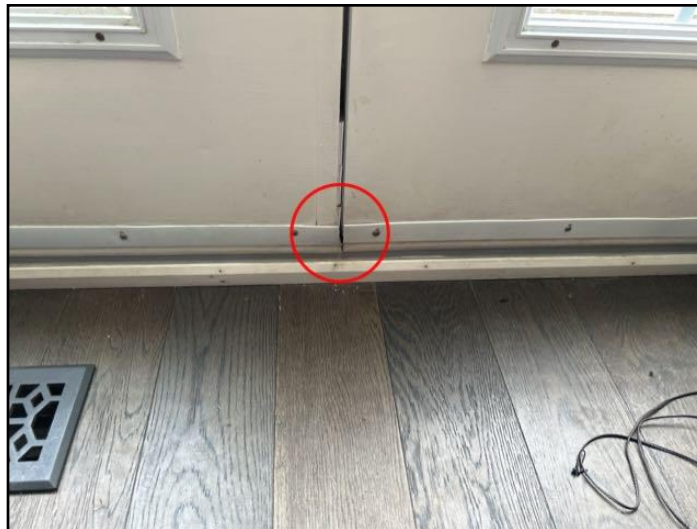
Condition: • [Weatherstripping missing or ineffective](#)

A cold draft at the bottom of the french doors suggests a weatherstripping issue.

Implication(s): Chance of water entering building | Increased heating and cooling costs | Reduced comfort

Location: Living Room

Weatherstripping missing or ineffective

Task: Further evaluation/repair
