Home Inspection Report

PROPERTY INSPECTED:
5 Gordon Park Drive
Toronto, ON M9B 1J5

Date of Inspection: 04/03/2024

Inspection No. 141465-887

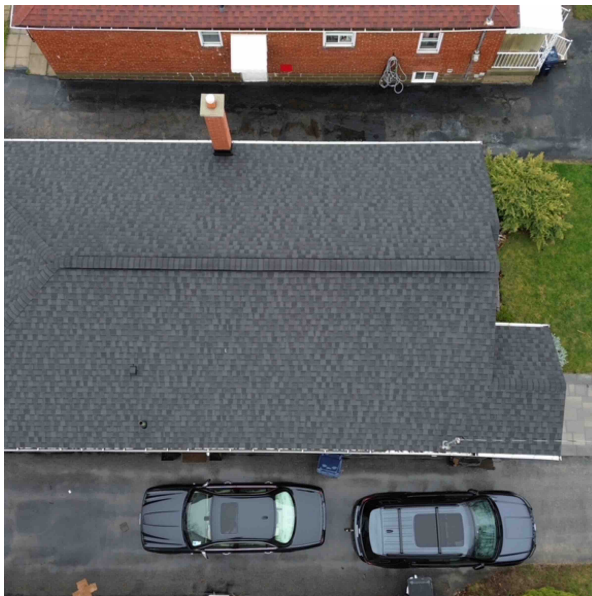
4.2.1 The roof system has the appearances of being newly installed and a warranty may be available.

4.2.2 The hip roof system has premium - fibreglass laminate style shingles applied with attic ridge venting.

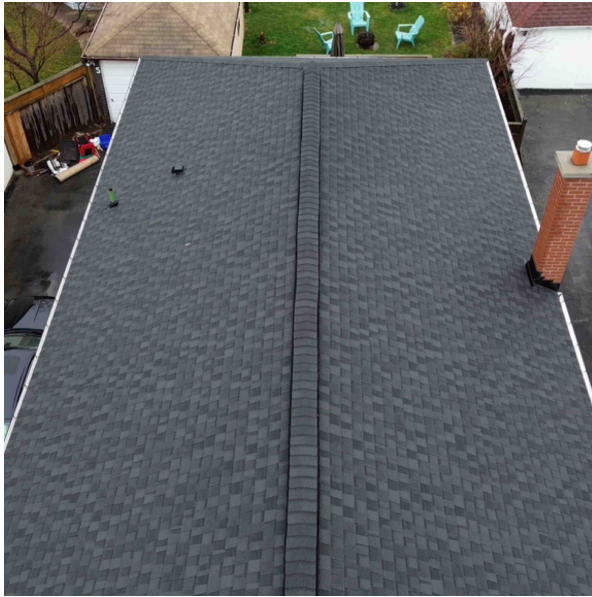
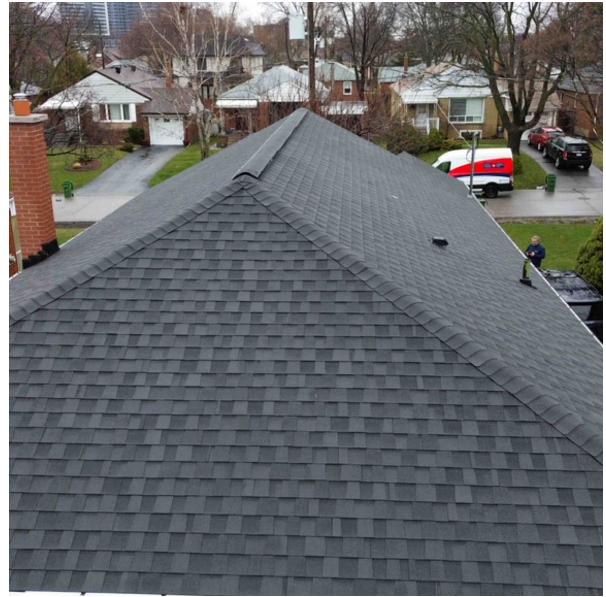
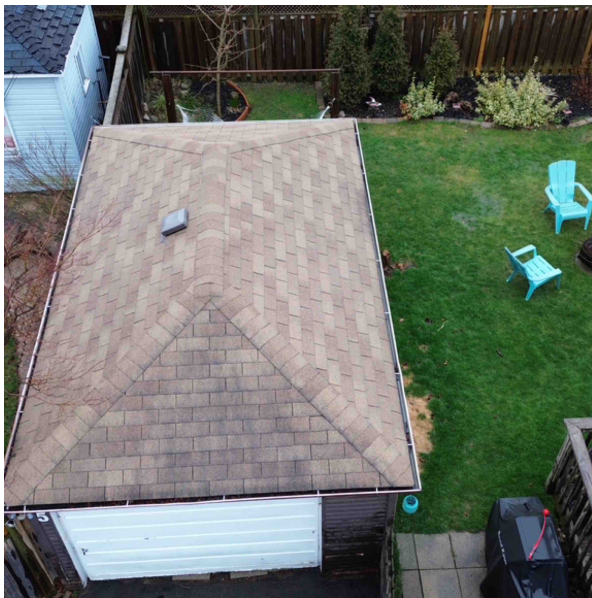
4.4.2 The dwelling is covered with laminated shingles, also known as architectural roof shingles or three-dimensional shingles, are thick, double-layered fiberglass roofing shingles that offer a bold and visually striking aesthetic to the roof system.

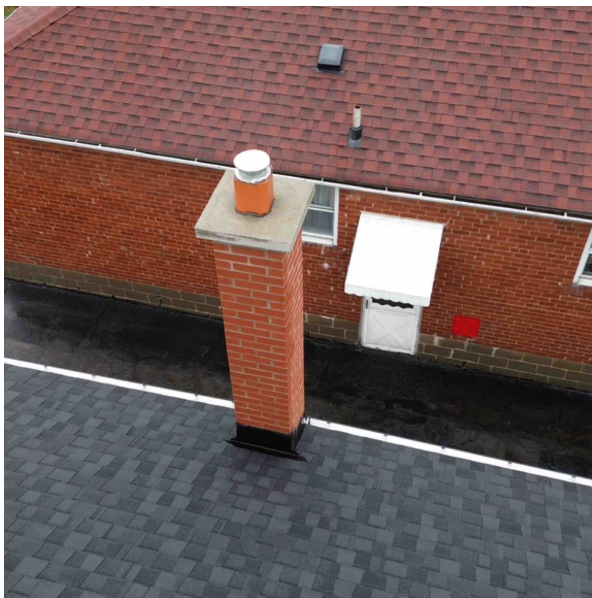
4.7.2 The masonry chimney is well maintained

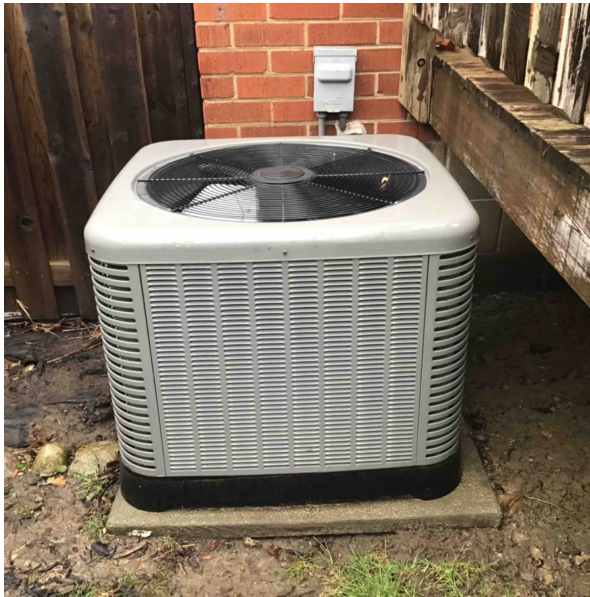
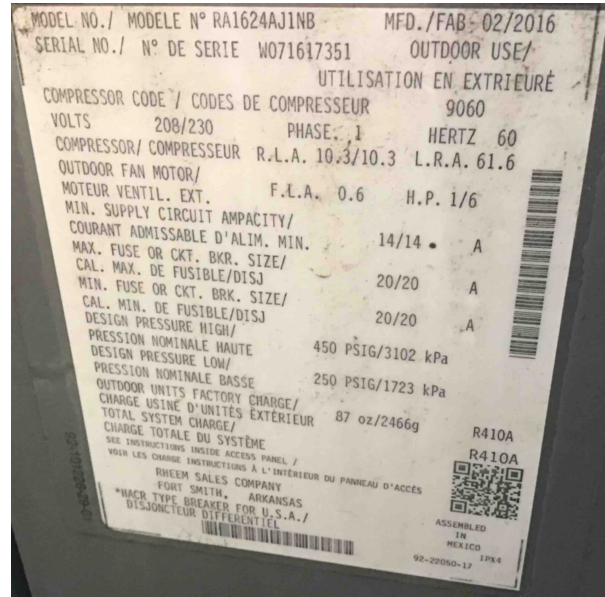
9.6.1 Air Conditioner is in the middle of its lifespan

9.6.2 Rheem Sales Company Central air Conditioning System
Model RA1624AJ1N8
Serial Number W0171617351
Assembled February 2016

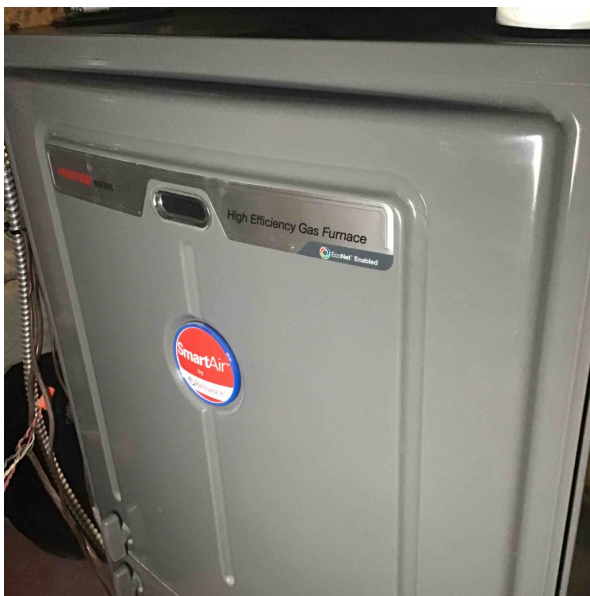
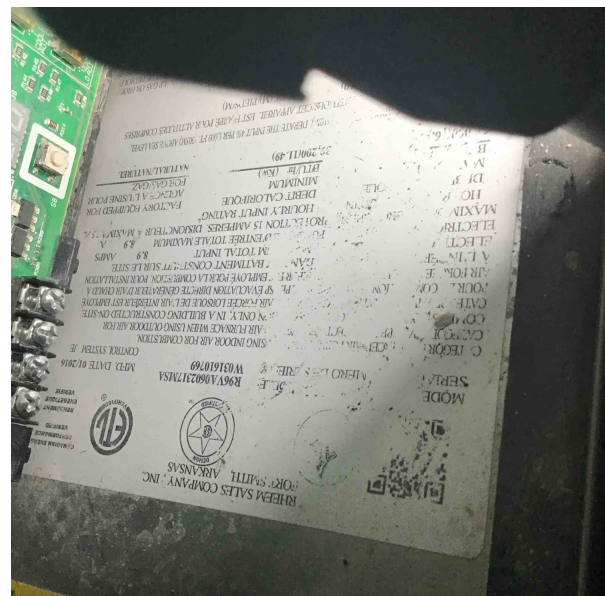
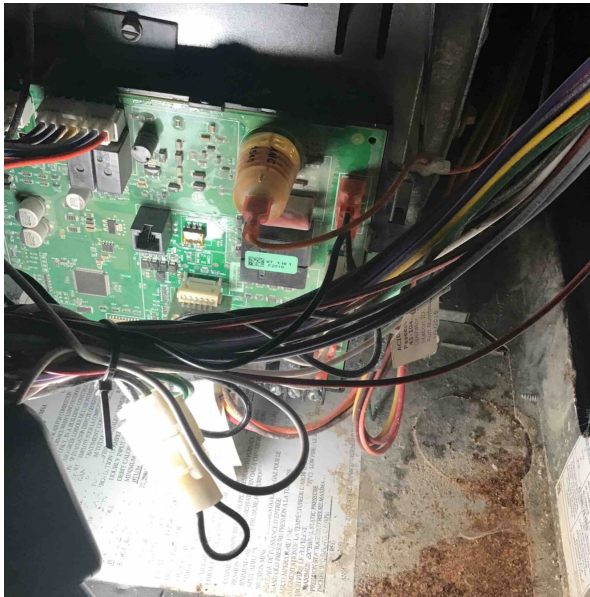
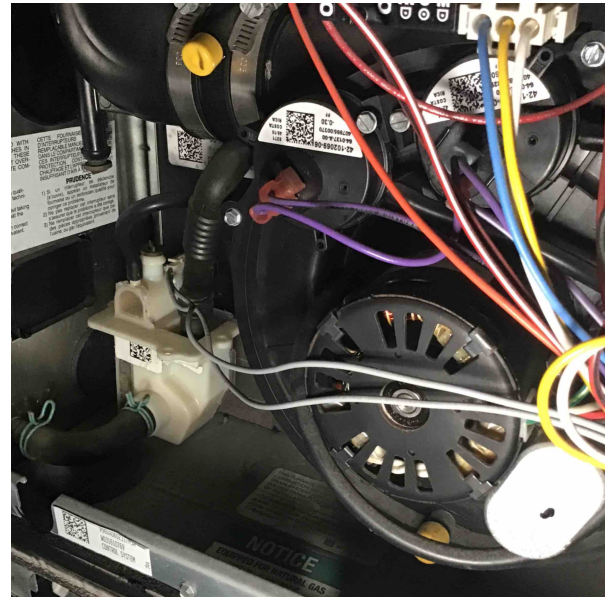
⦿ Rheem Sales Company - Natural Gas High Efficiency Furnace

Serial Number W031610769

The unit is in the middle of its lifespan and we suggest it be serviced

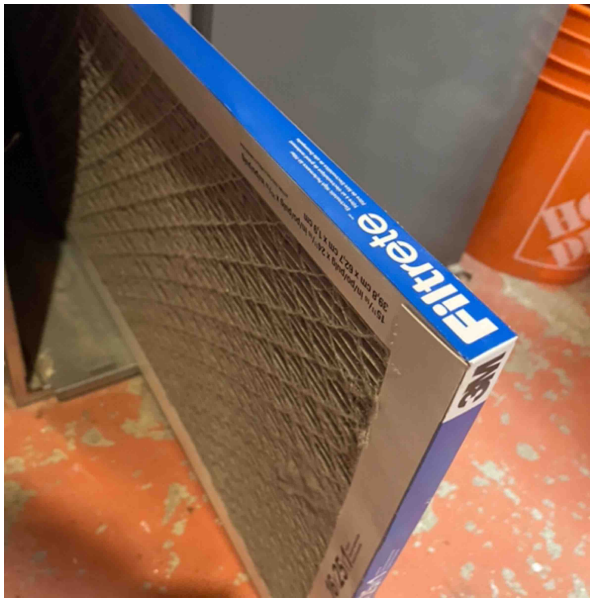
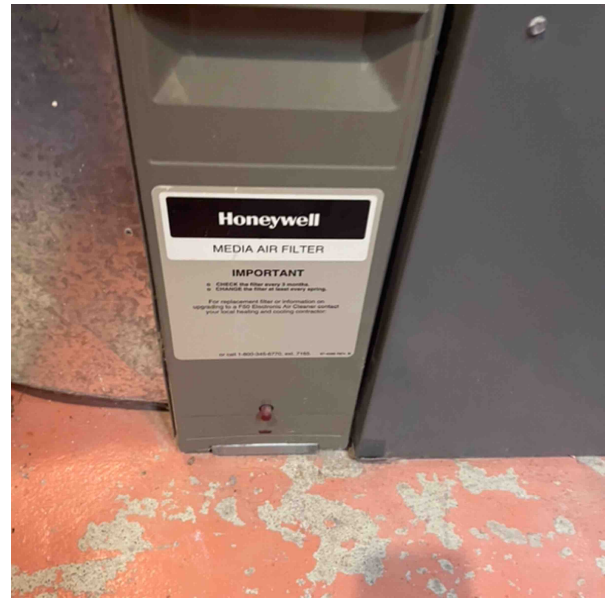
9.11.3 The dwelling has been outfitted with a high efficiency filter unit. We would suggest that the furnace filter be changed or cleaned upon occupancy and quarterly inspections be performed. Dirty filters affect HVAC lifespan.

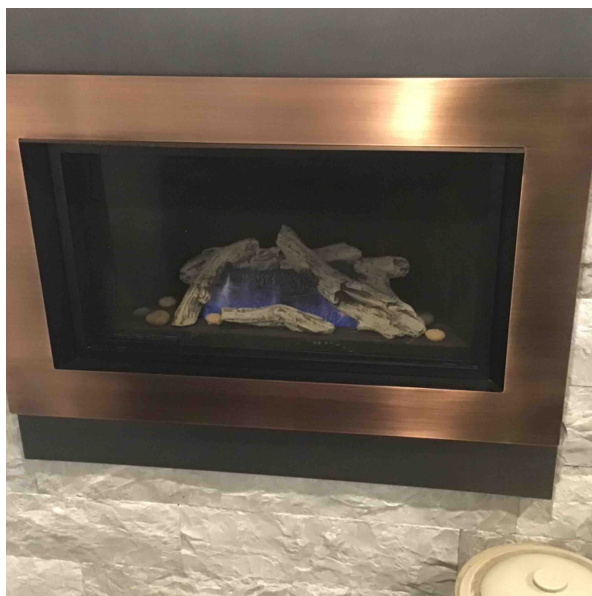
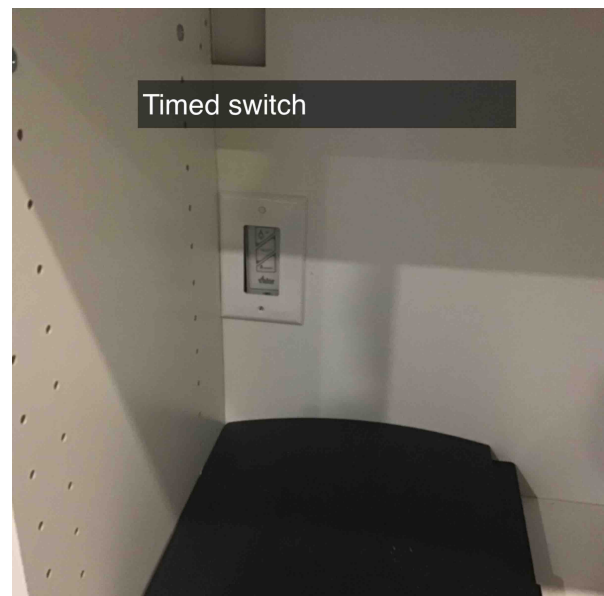
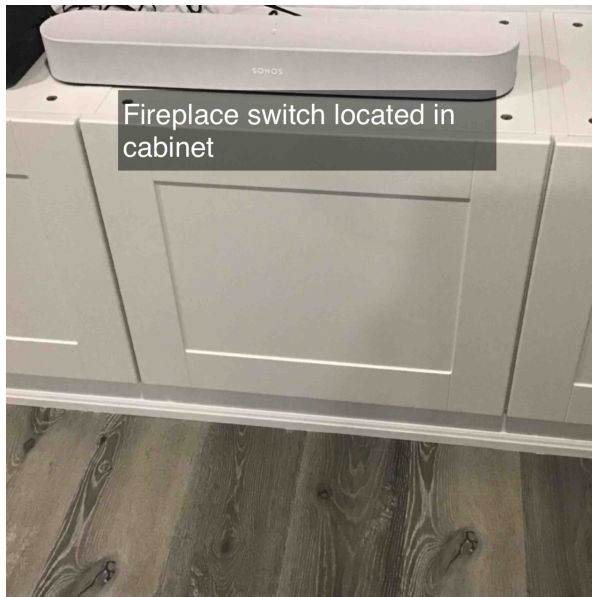
- ☑ Valor Glass face natural gas fuelled fireplace

12.1.1 The dwelling has a glass faced gas fireplace. **(Recreation Room)**
