Your Inspection Report

5 Risdon Court
Toronto, ON M9C 4E6

INSPECTION DATE:
Wednesday, April 10, 2024

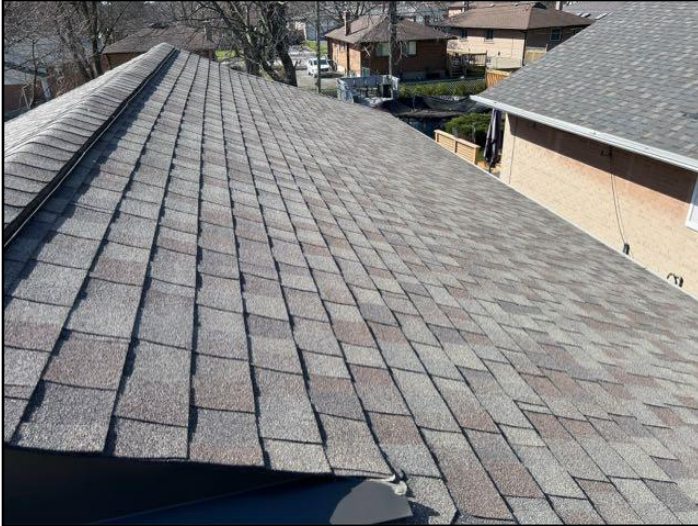
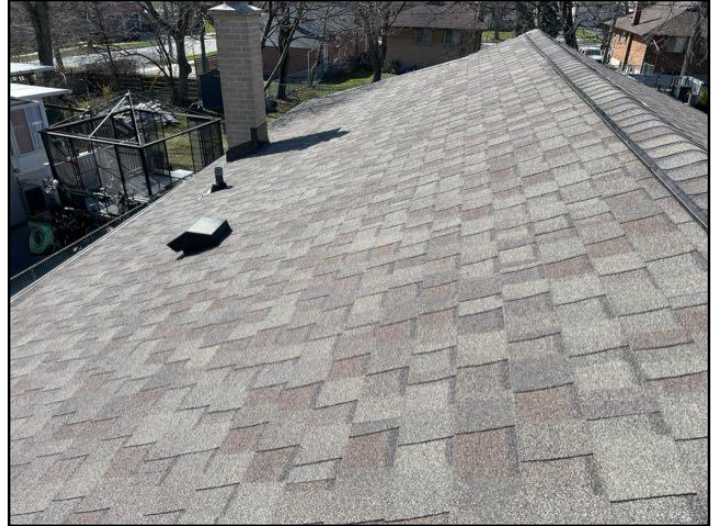
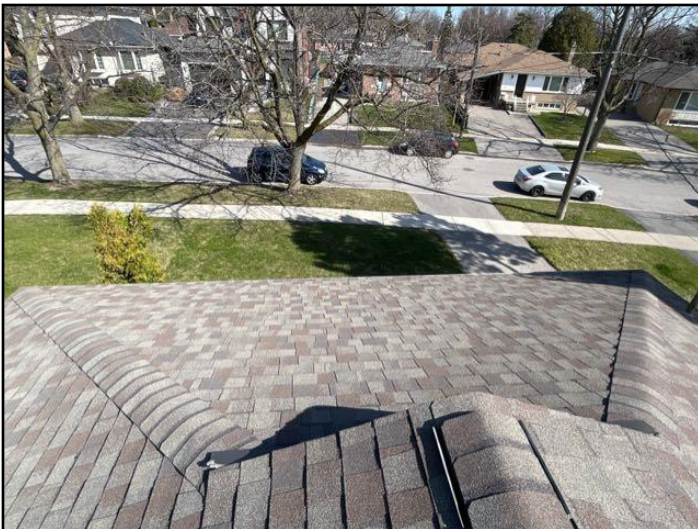
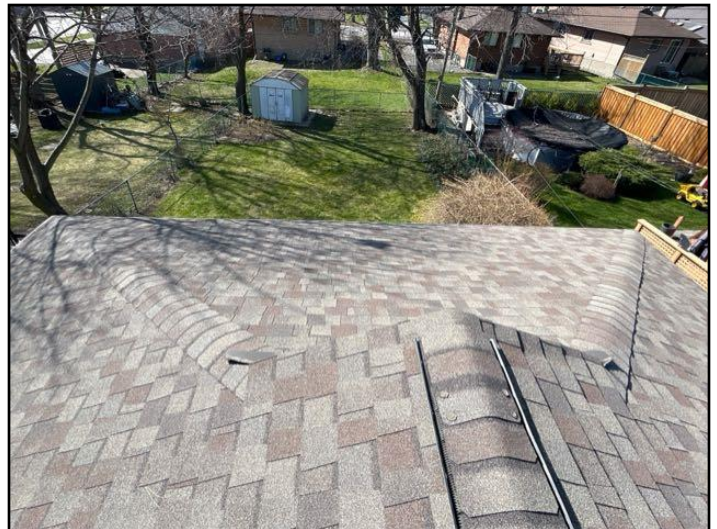
Asphalt shingles

Condition: • Roofing material appears to be in good condition. Seller reports that the roof was last replaced in 2015.

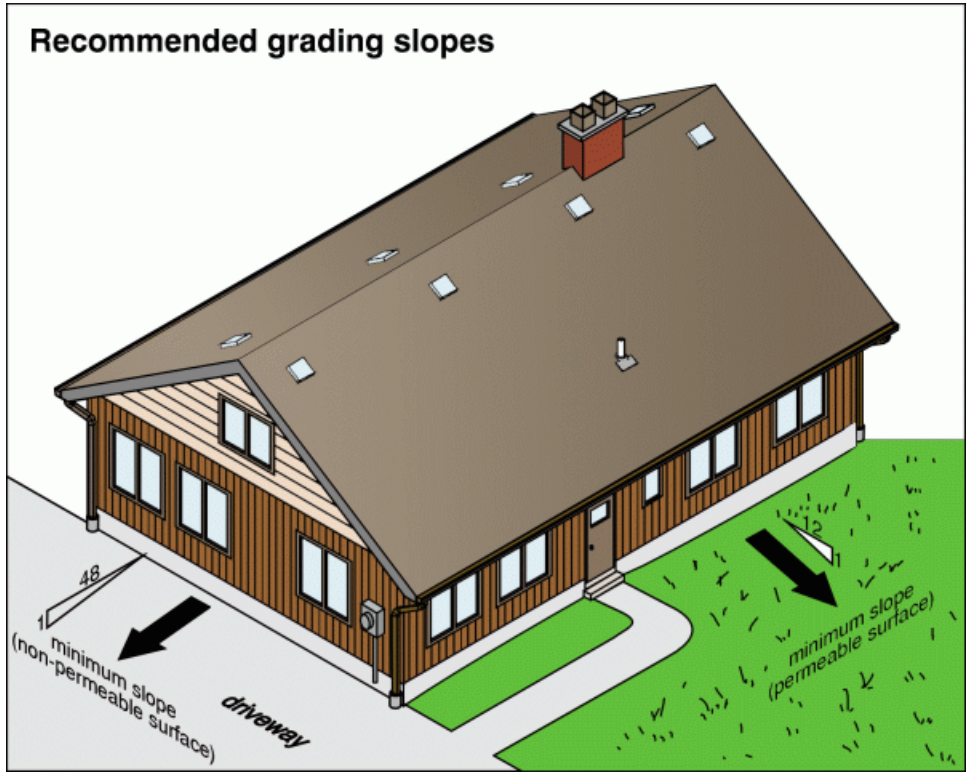
Swales

Condition: • [Improper slope or drainage](#)

Implication(s): Chance of water damage to structure, finishes and contents

when the overall lot drainage is toward the house, swales can be used to direct surface water away from the foundation

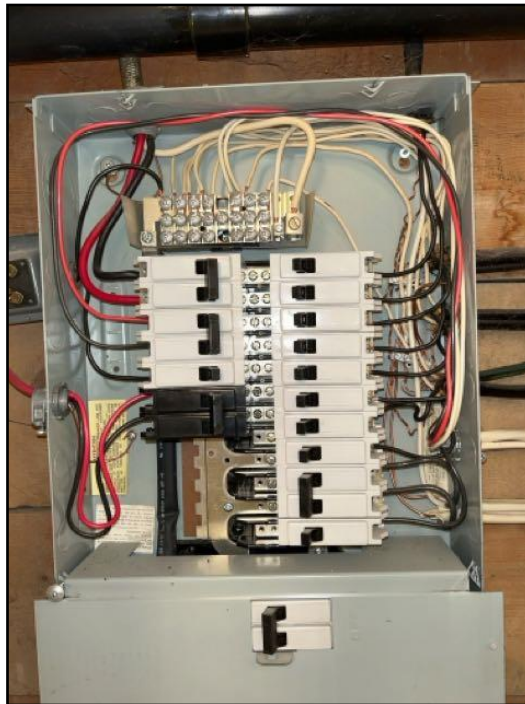
Breakers - basement

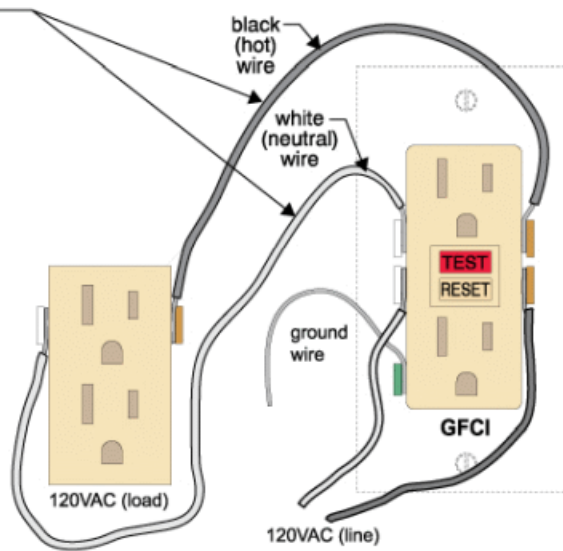
Condition: • [No GFCI/GFI \(Ground Fault Circuit Interrupter\)](#)

if there is a difference of at least 5 milliamps, there is a current leak and the GFCI shuts off the outlet and all outlets downstream

if the GFCI is in the panel, the entire circuit will be shut down to reduce the risk of electric shock

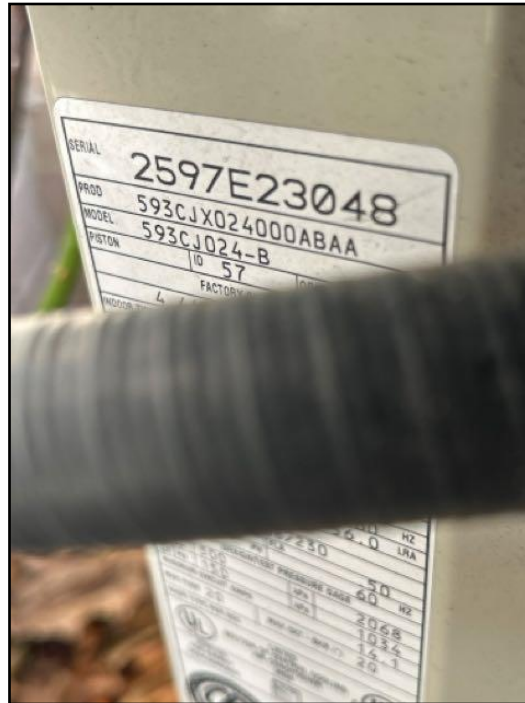
Air conditioner data plate

Condition: • [Old](#)

Implication(s): Equipment failure | Reduced comfort

Task: Replace

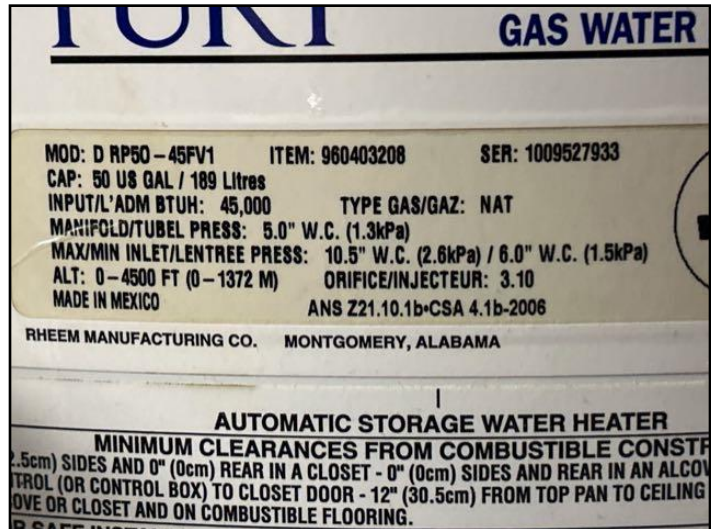
Water heater data plate

Condition: • [Near end of life expectancy](#)

Task: Replace

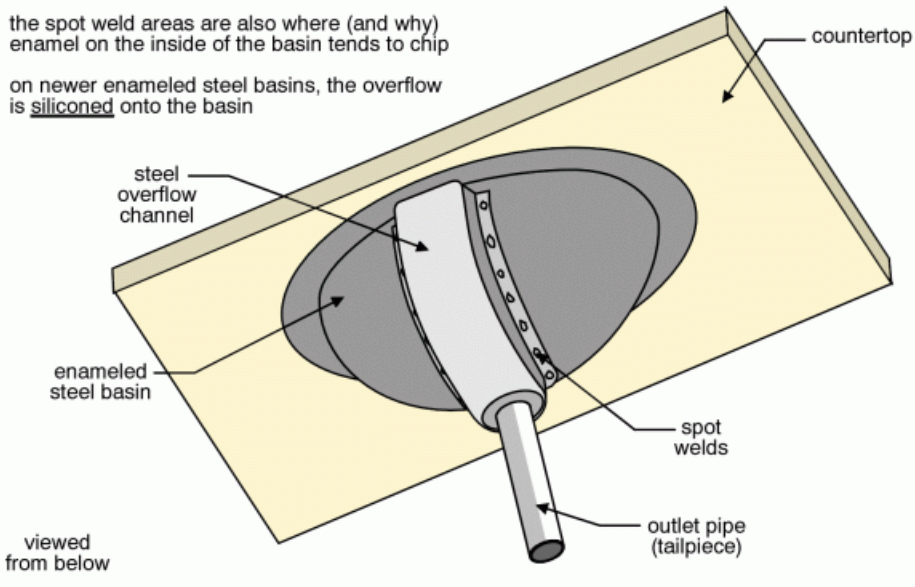
Condition: • [Rust](#)

Implication(s): Chance of water damage to structure, finishes and contents

Rusting overflow

rust starts to develop where the overflow is spot welded to the basin

the rust can spread and ultimately eat through the basin (or overflow) causing leakage

Sink replaced, as per Estate Trustees.
